Terramar Environmental Services, Inc.  
1241 Crane Boulevard  
Sugarloaf Key, Florida 33042  
(305) 393-4200 [terramar@bellsouth.net](mailto:terramar@bellsouth.net)

## MEMORANDUM

RE: KEYS Hurricane Irma Emergency Repairs, Line 4 Damage Assessment

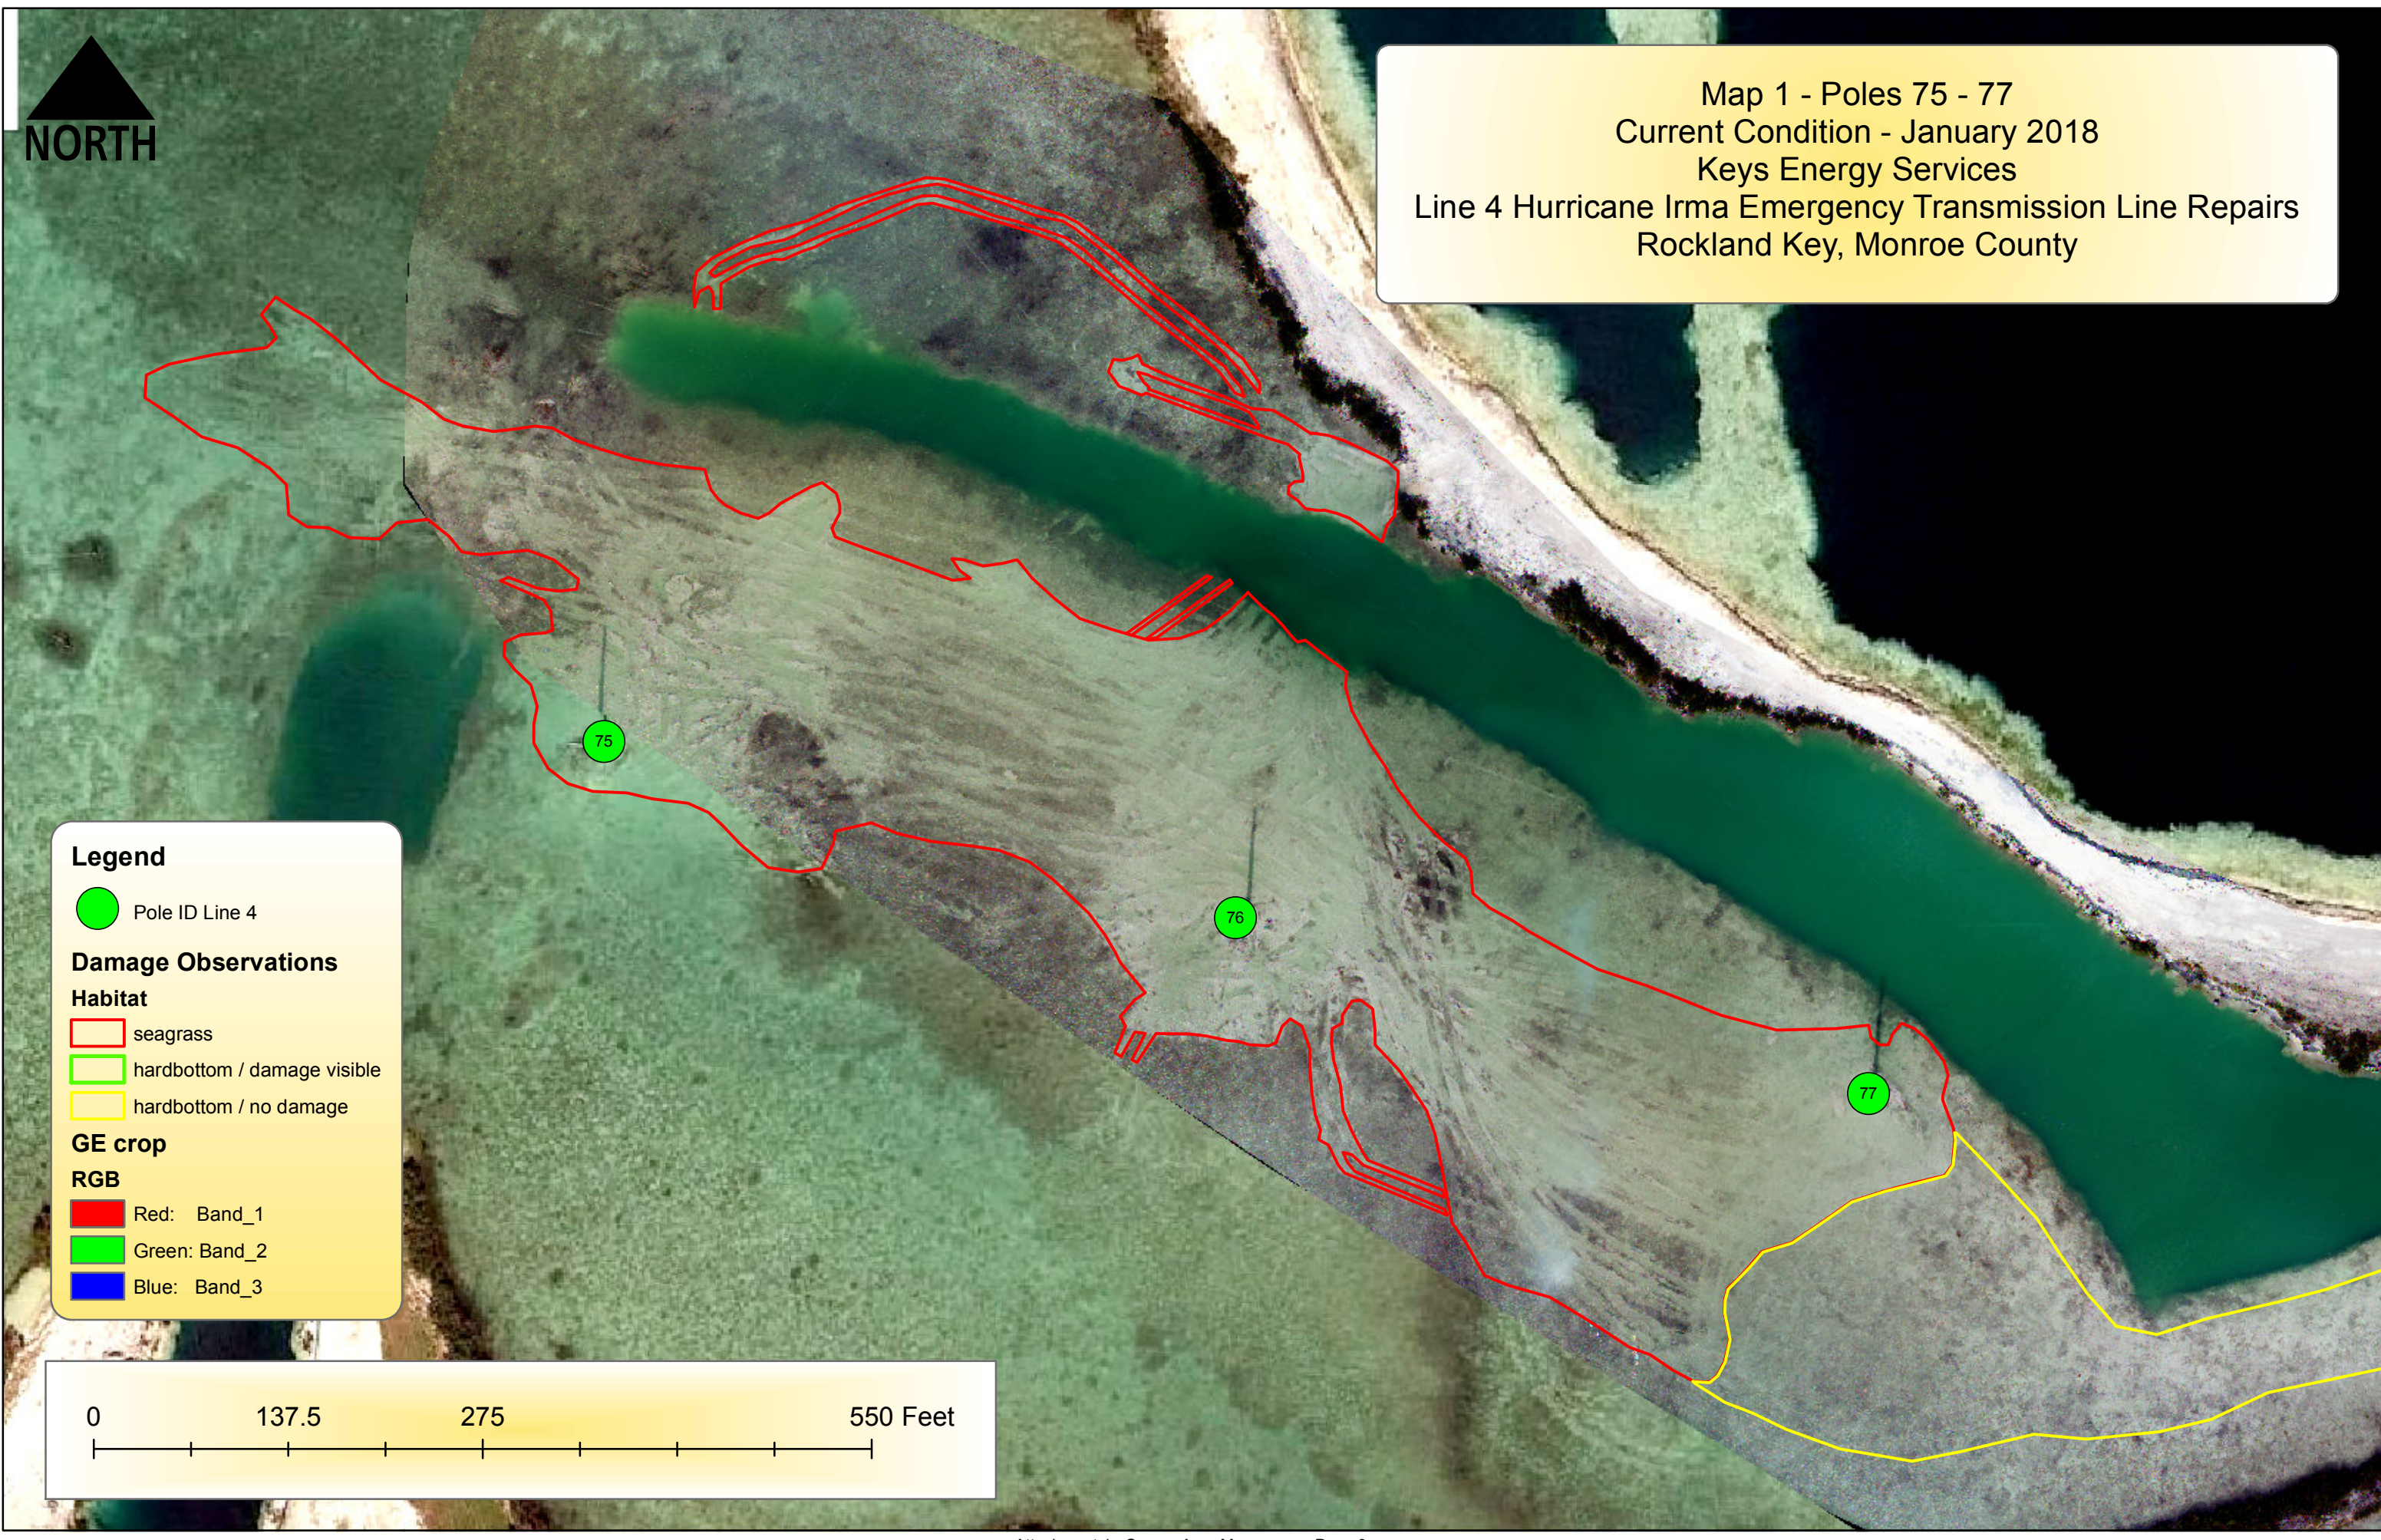
Map 1 - Poles 75 - 77  
Current Condition - January 2018  
Keys Energy Services  
Line 4 Hurricane Irma Emergency Transmission Line Repairs  
Rockland Key, Monroe County

Observable damage to benthic habitats was estimated to be 10.5 acres, with the majority of that in seagrass habitats where deep, soft sediments made the habitat susceptible to equipment damage (Attachment 1 – Maps). Benthic damage was observed in two main locations; poles 75-77 and poles 80-81. Benthic damage at 78 was accomplished by placing a barge across the dredged channel and then working from the barge, limiting the need for the excavators to maneuver in this area. In addition, the area surrounding pole 78 was hardbottom which exhibited less damage than seagrass habitats.

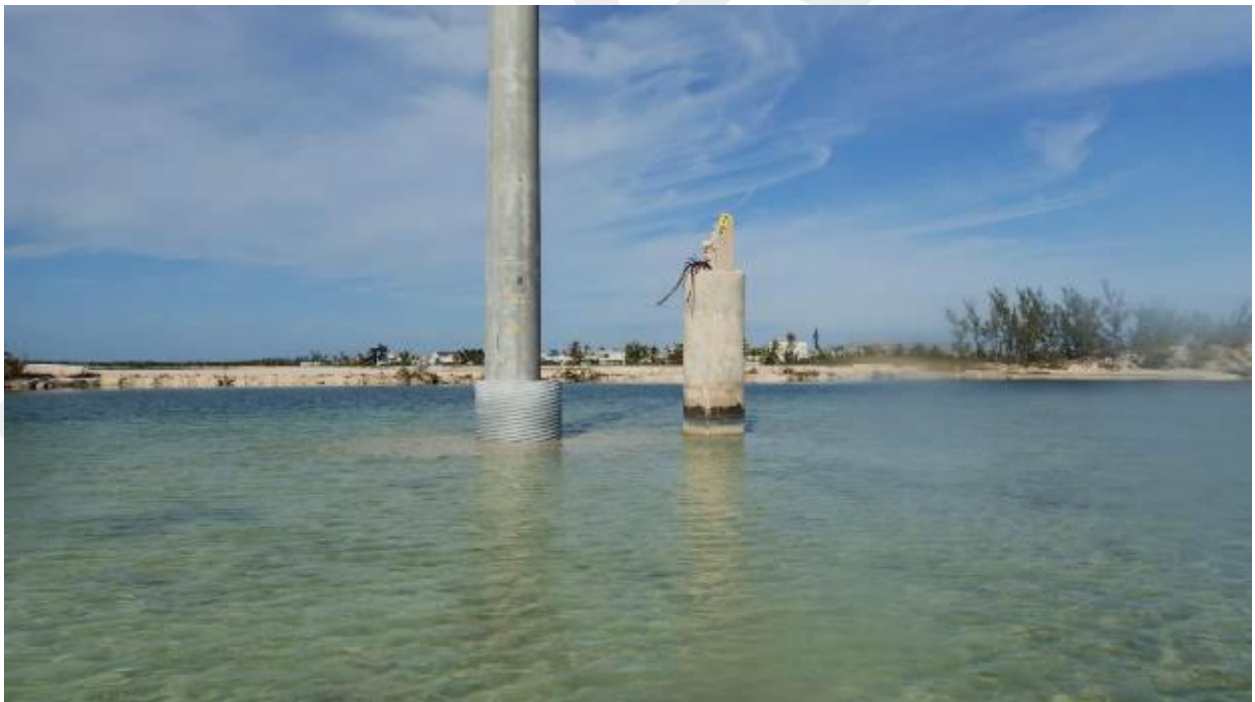
Replacement pole showing casing installation and stub at Pole 78. January 2018.

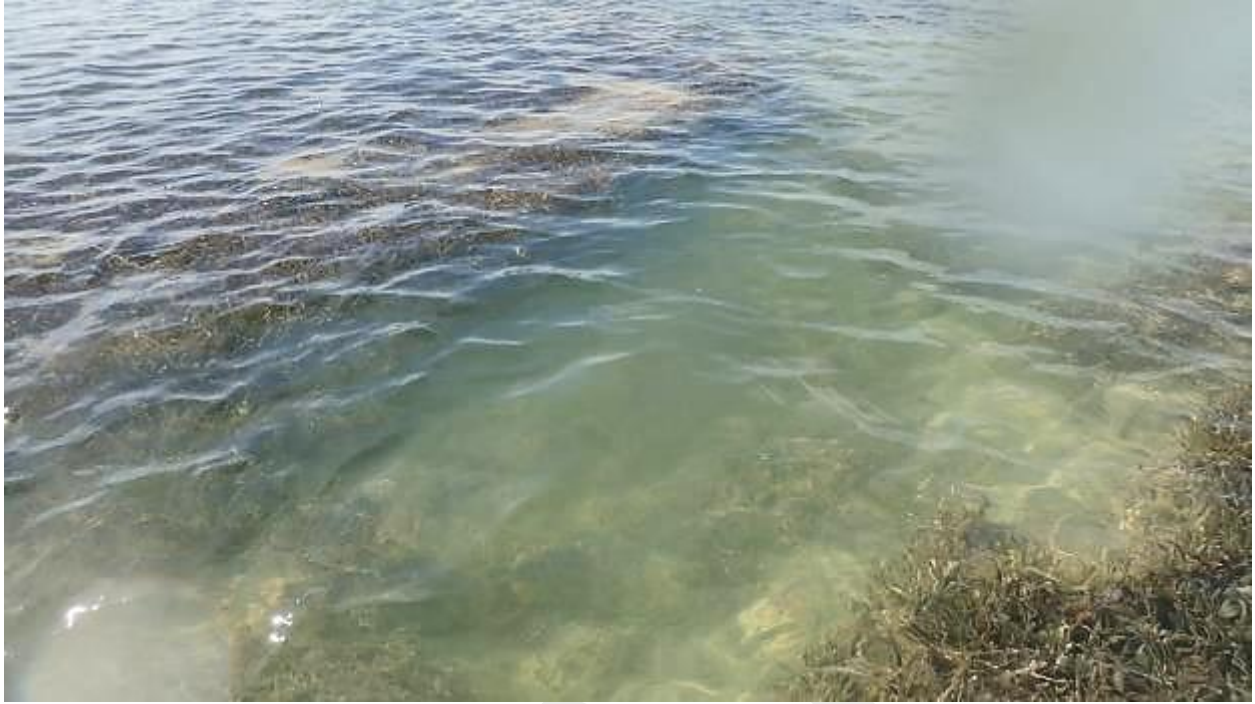
Damaged seagrass habitat with trenches and berms visible. January 2018.

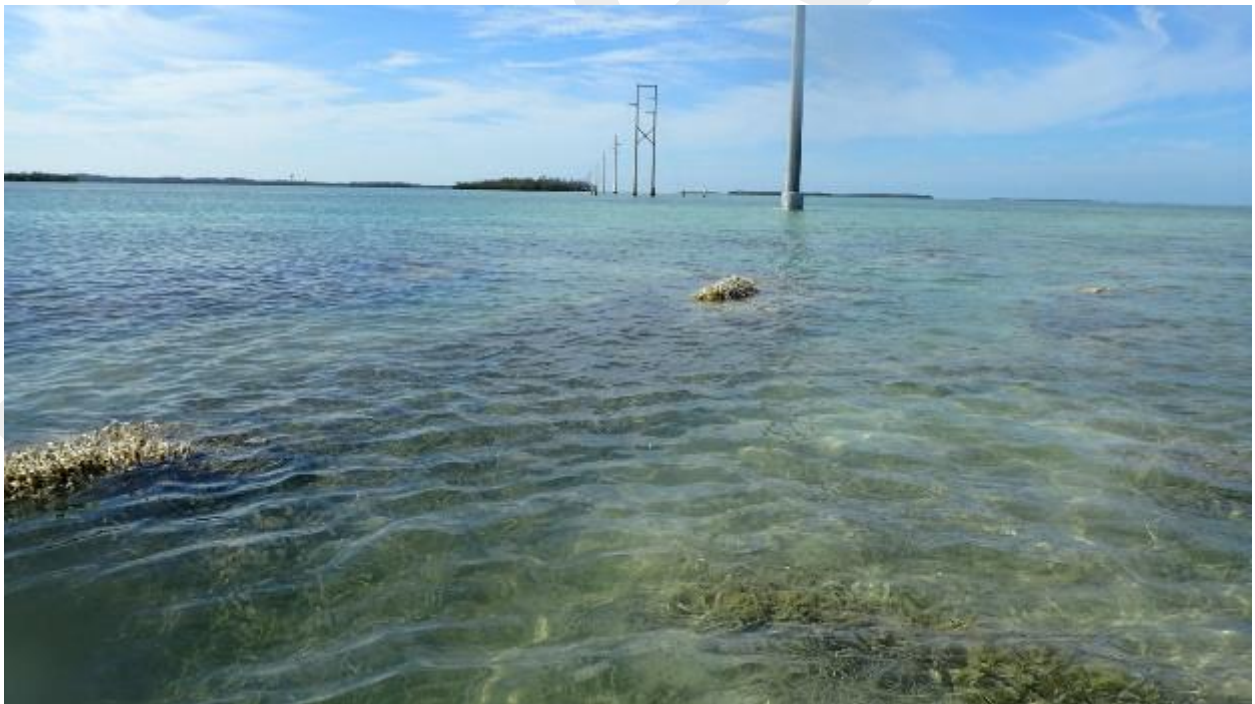
Damaged dense seagrass habitat with trenches and berms visible. January 2018.

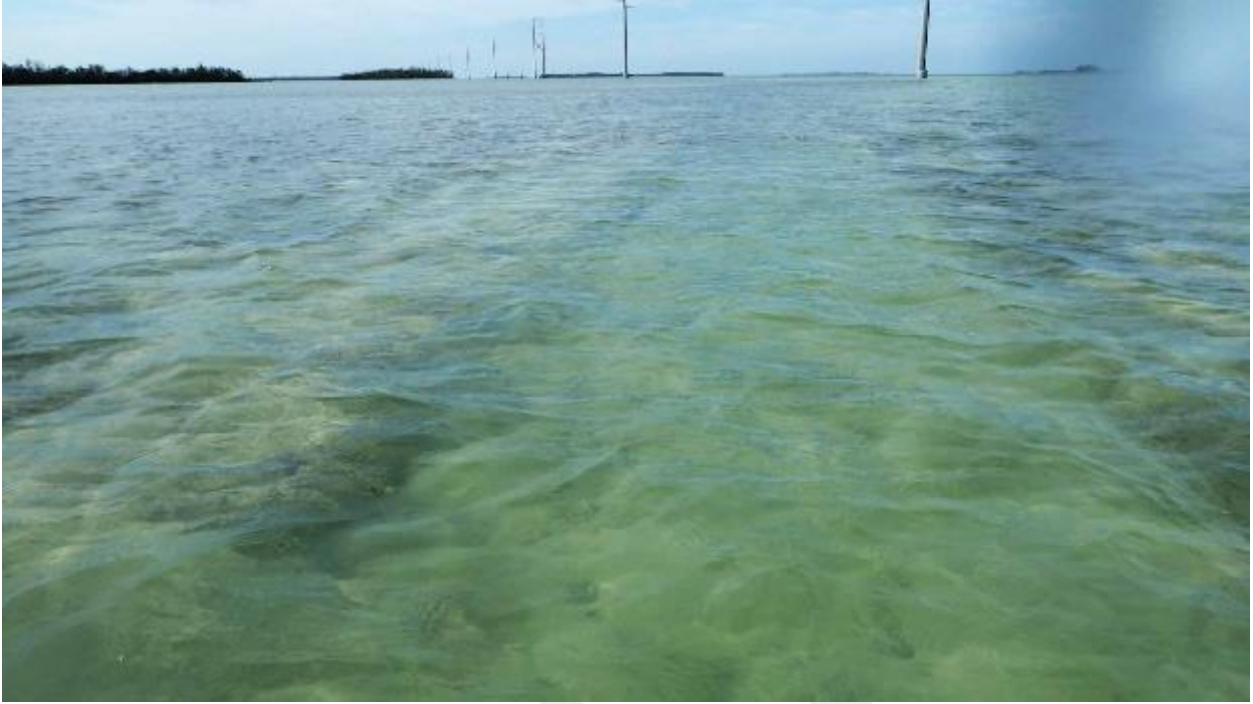
Damaged dense seagrass habitat with trenches visible. January 2018.

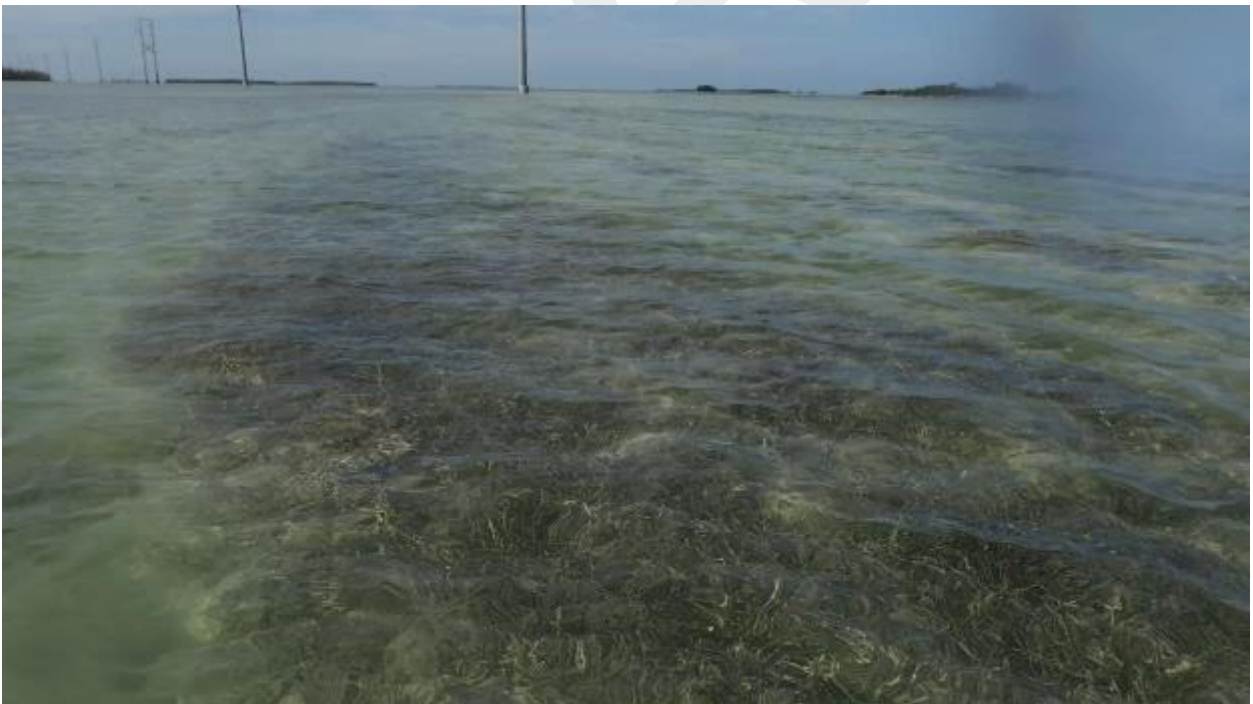
Damaged dense seagrass habitat with trenches visible. January 2018.

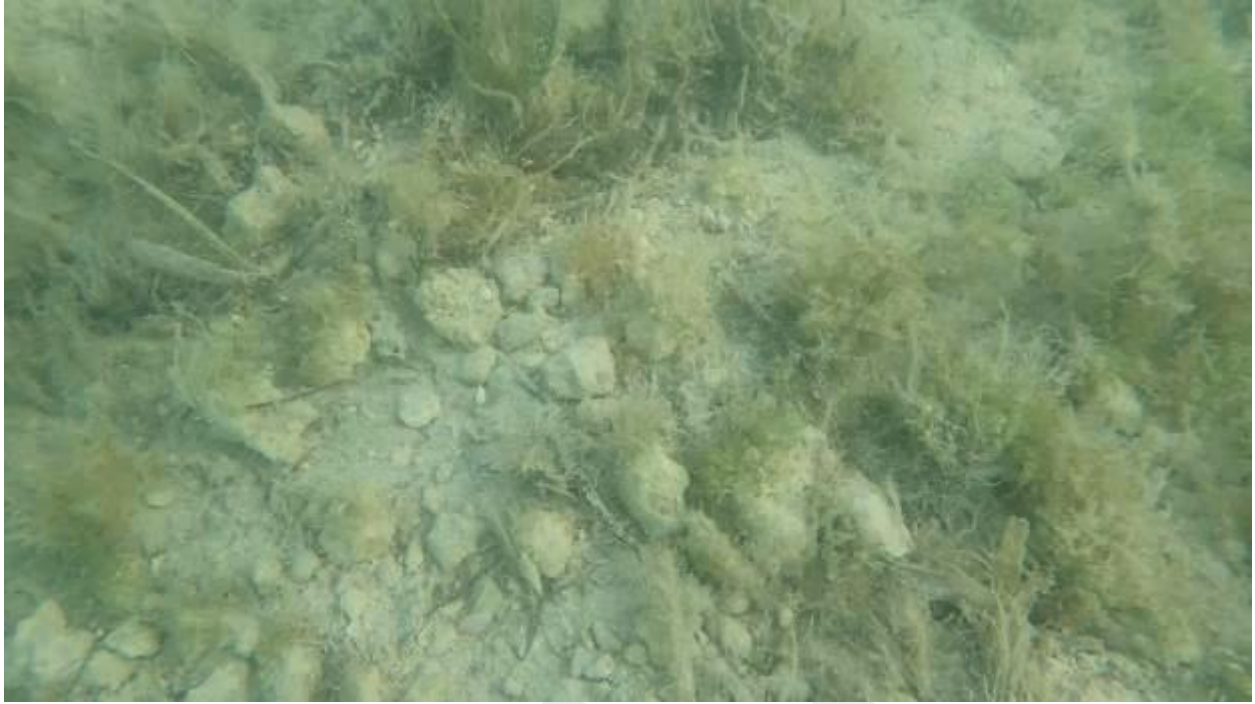
Damaged hardbottom habitat with surface scarification evident. January 2018.

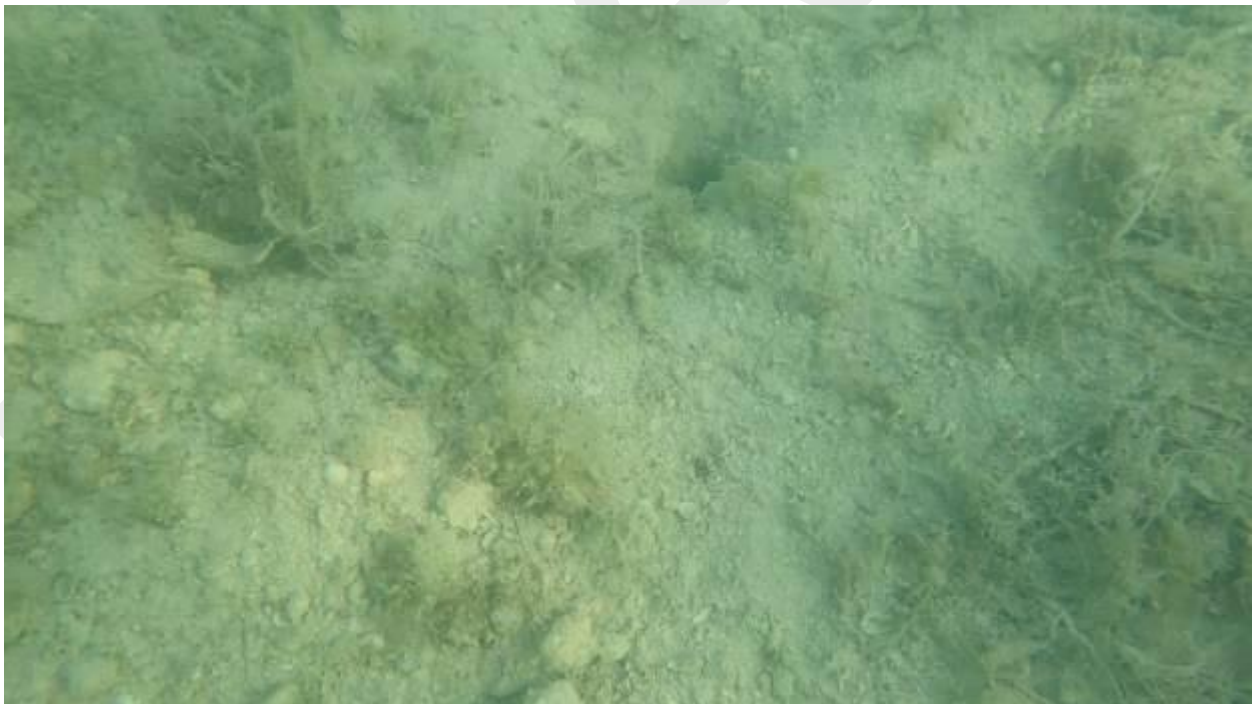
Damaged hardbottom habitat with surface scarification evident. January 2018.
