# Cudjoe Key Project

Update meeting and report

Cudjoe Key, March 19,2015

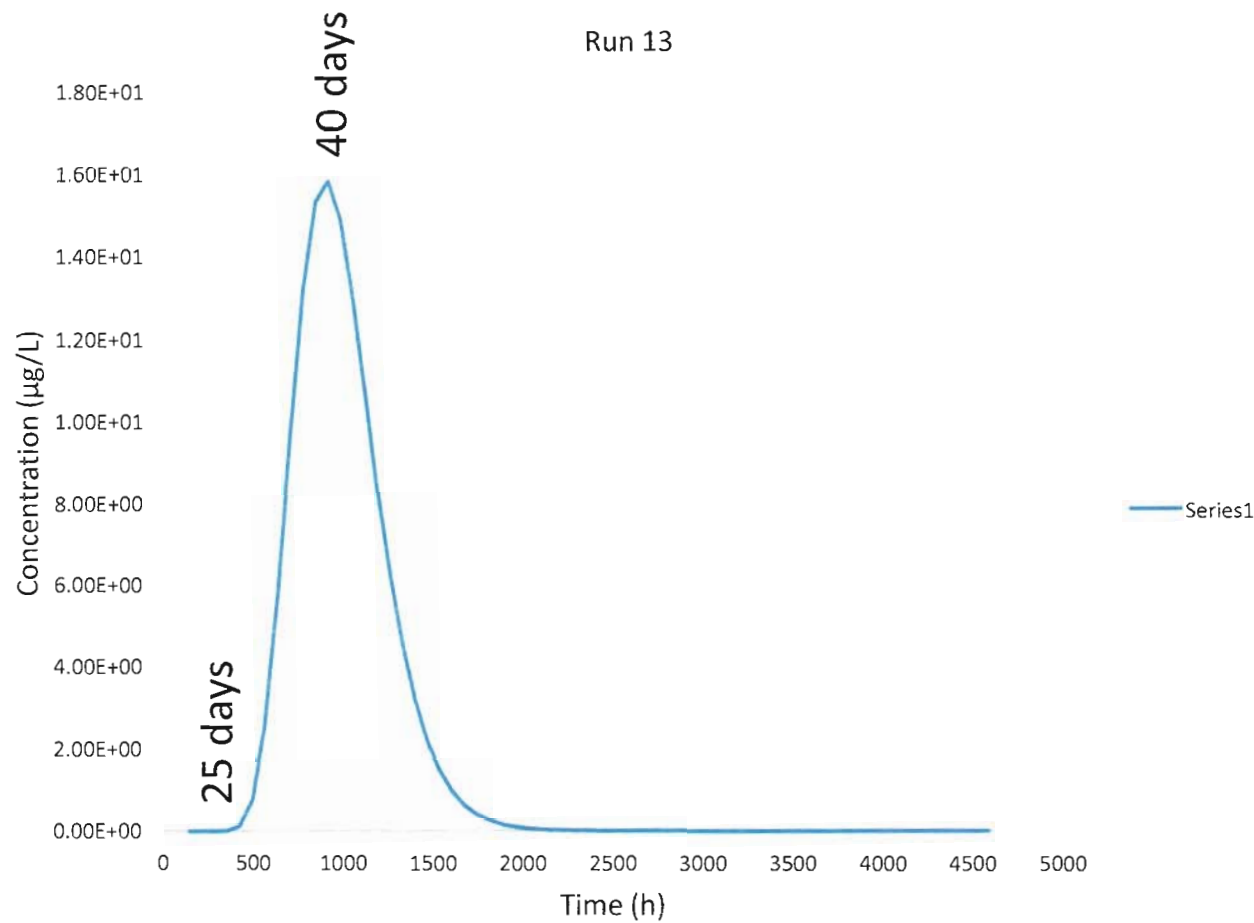
Estimated evolution of the tracer concentration at a measurement point located 500 m away from the injection well. For this case, the detection threshold is surpassed 620 hours approximately after the tracer injection. The concentration peak happens 902 hours after the injection.

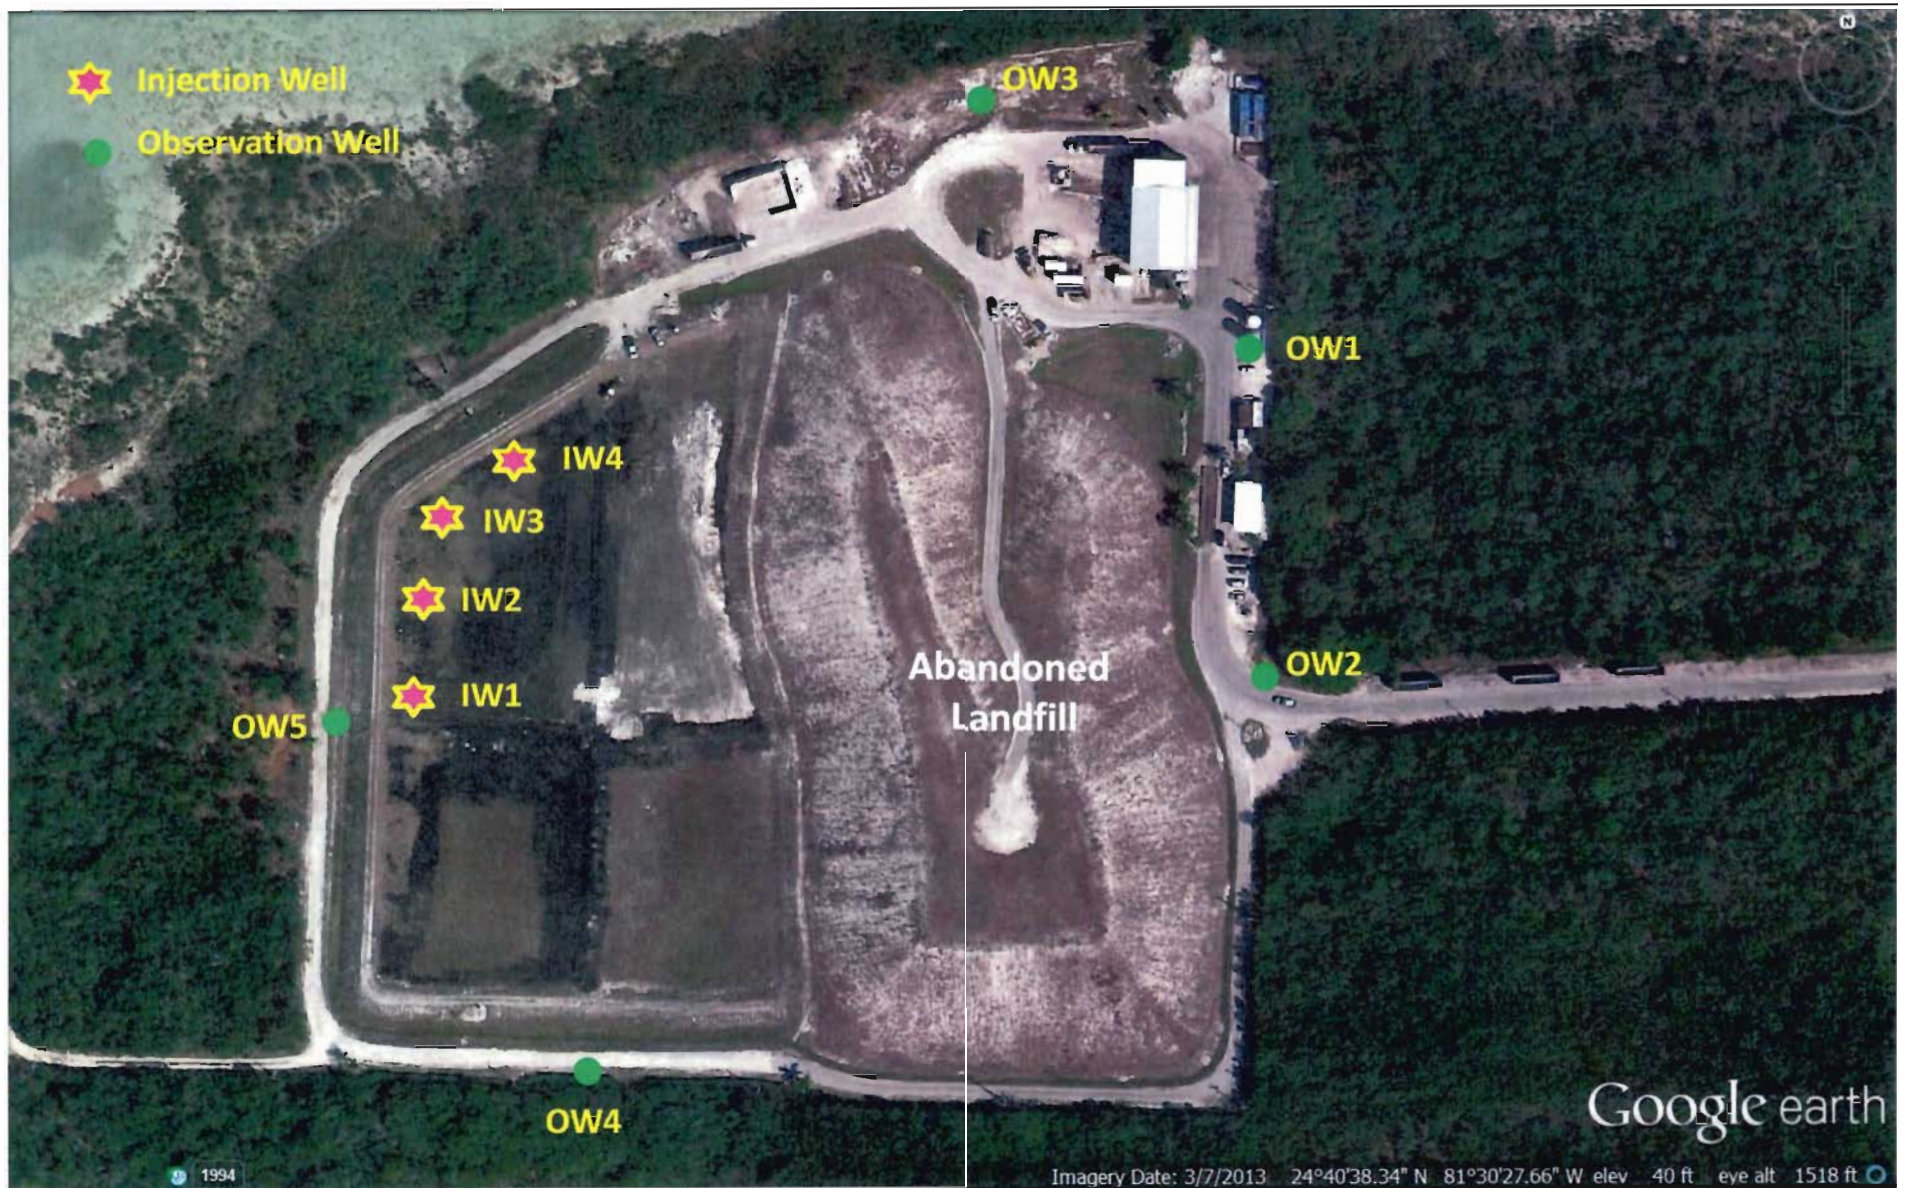
We are monitoring OW1, OW2, OW4, OW5 and IW1 and IW4. Dye Injection was through IW3

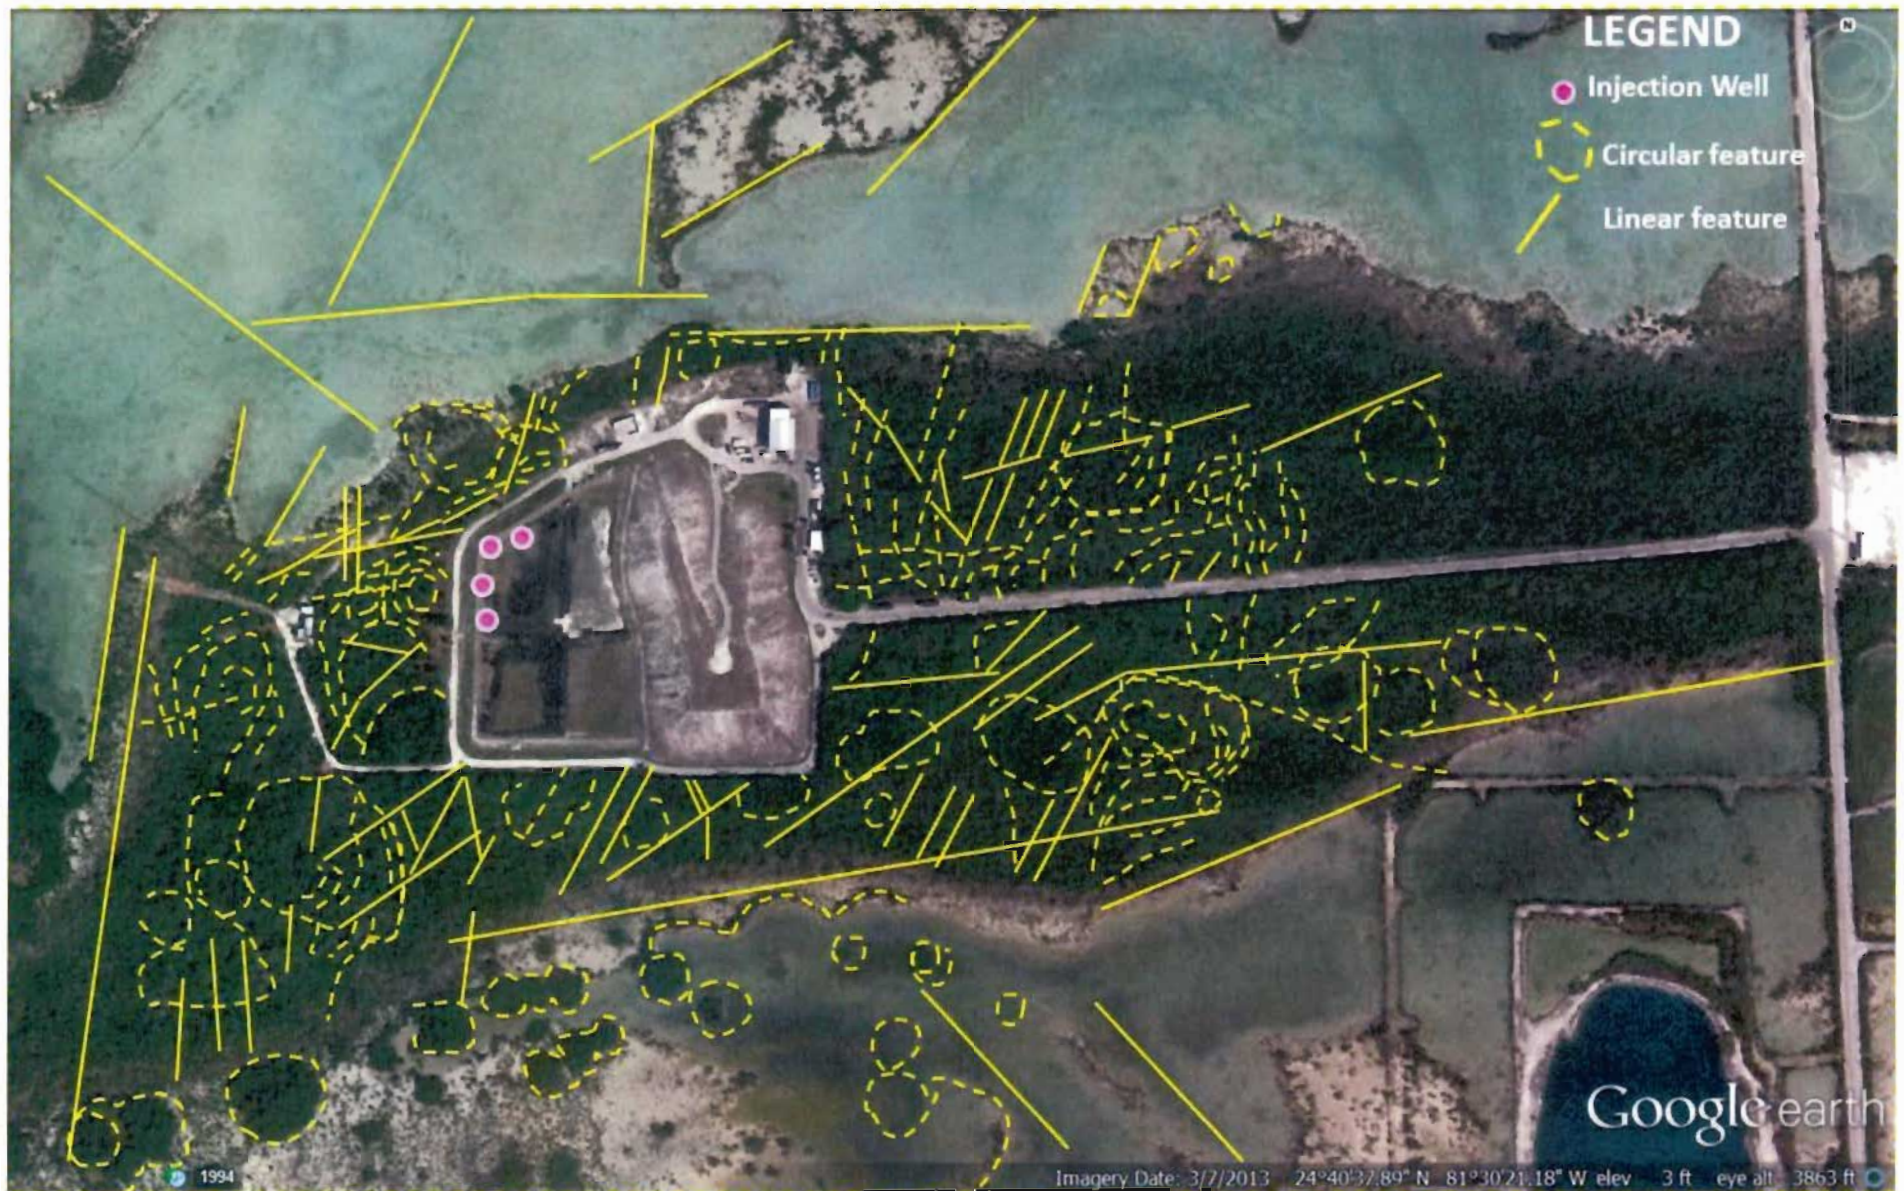
Google image showing potential fractures and karst features.  
Ground “thruthing” several of these features has confirmed the validity of the  
remote sensing interpretation

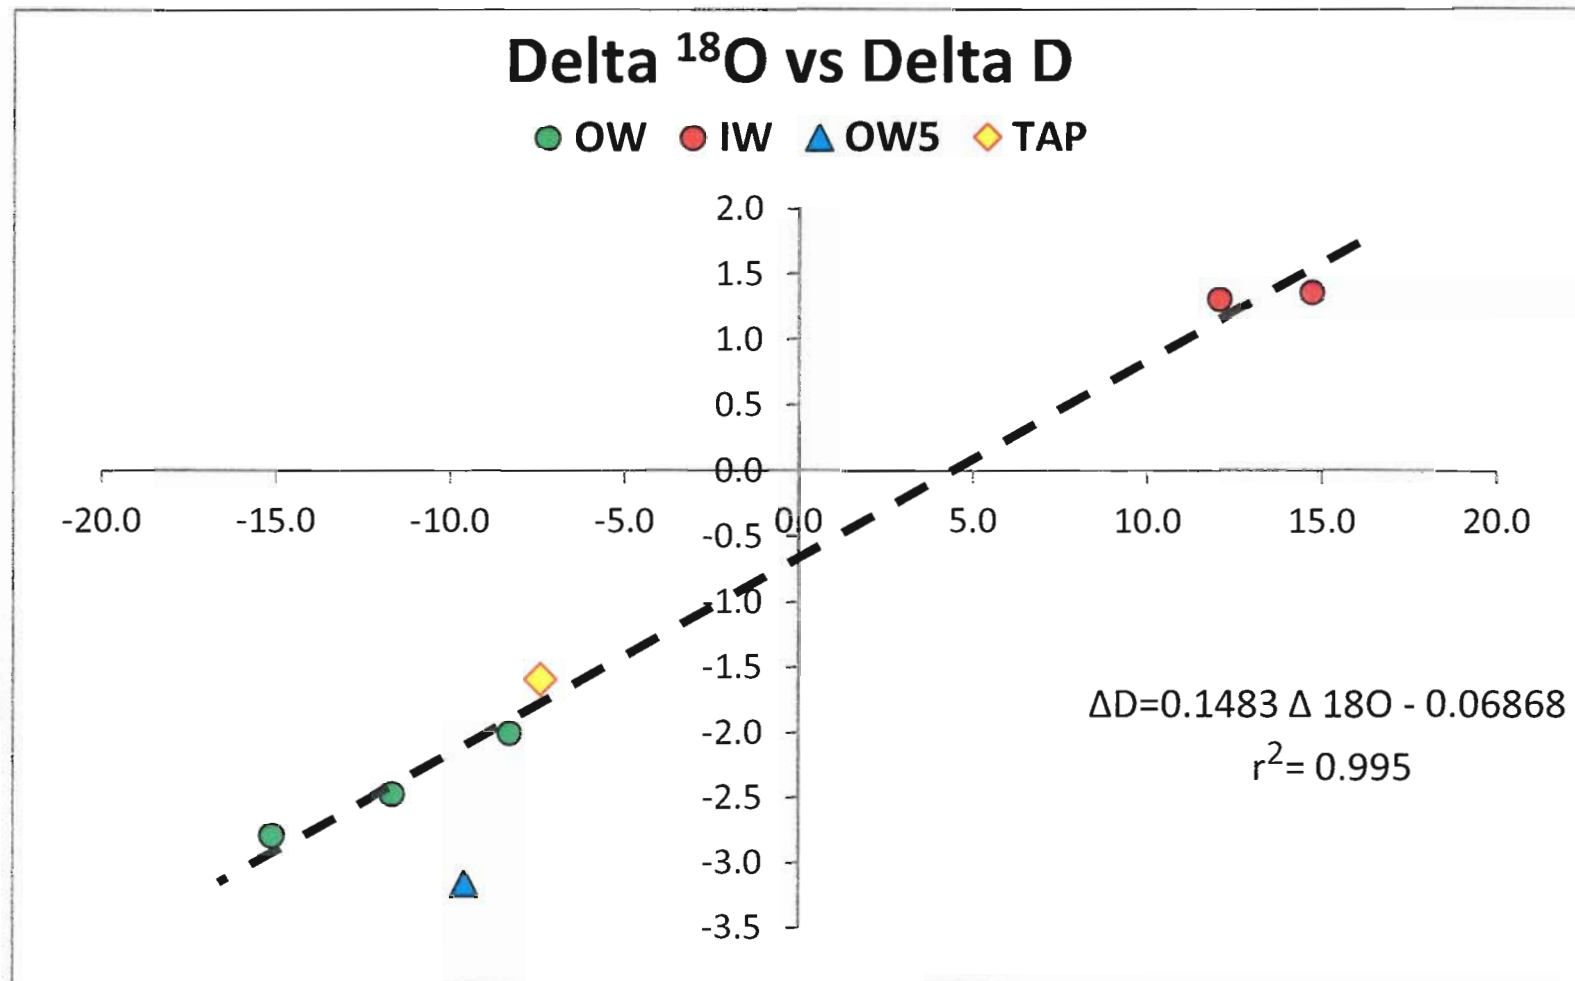
Surface and “deep” ground waters are isotopically different and plotted points fall along a straight line. OW5 is the odd one, with yellowish water, perhaps preferentially draining from the landfill

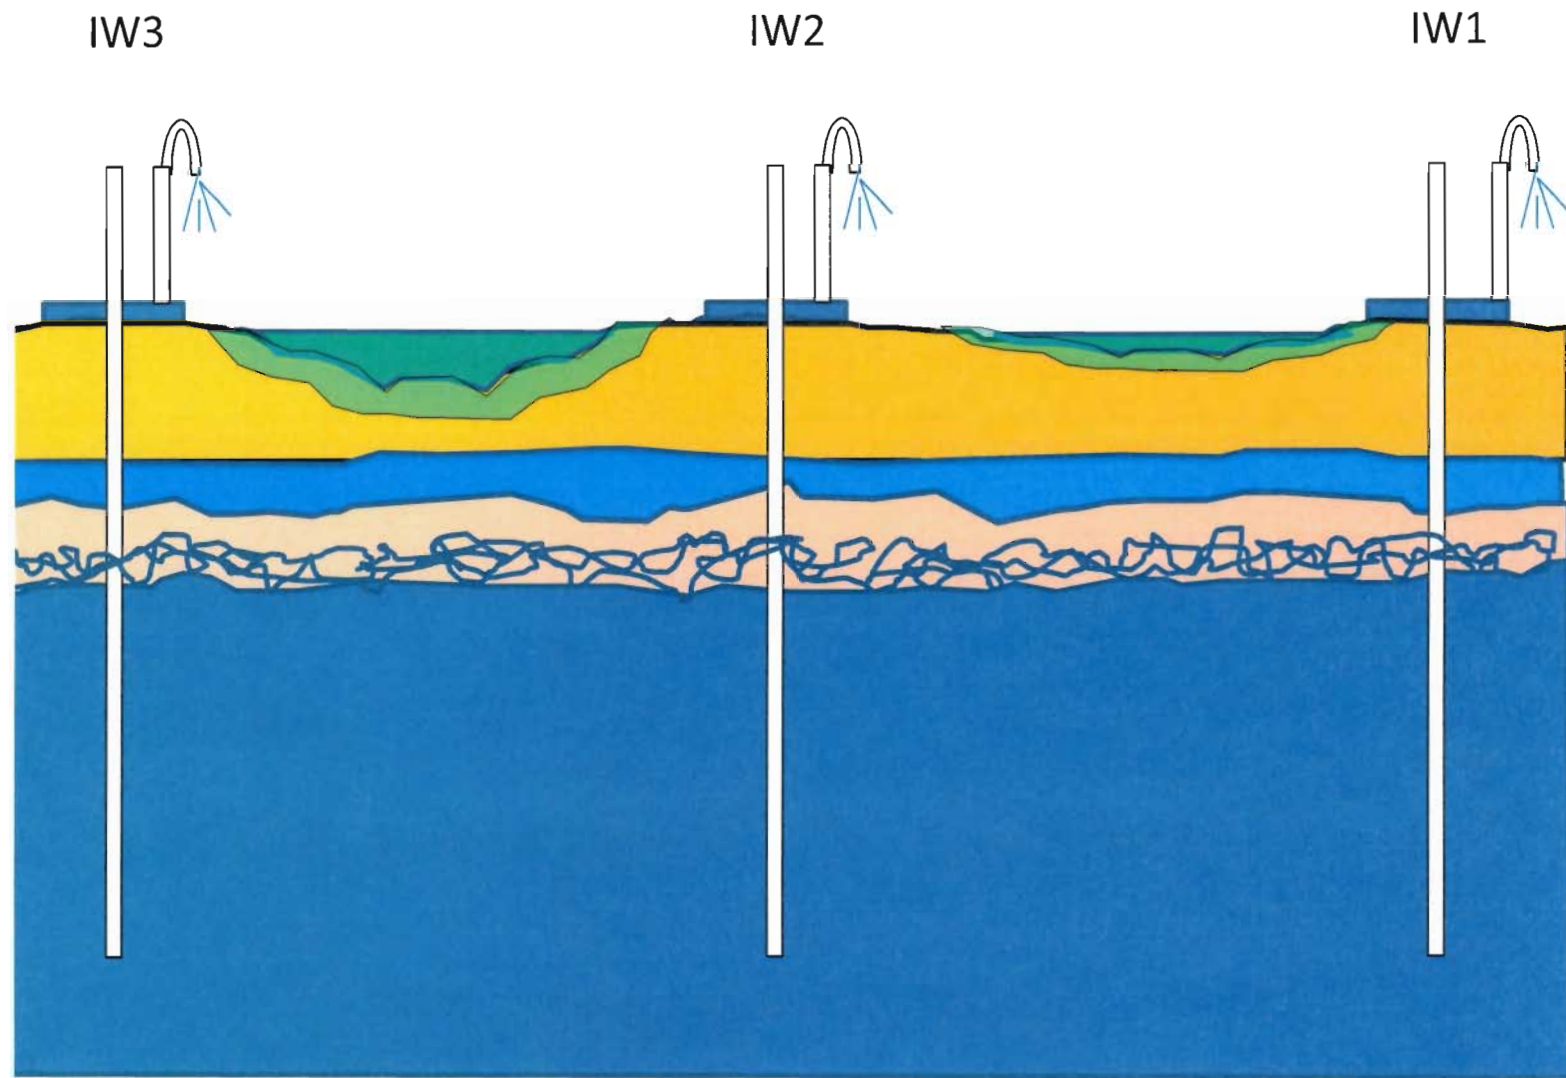
**Fresh water flooding and ponding during freshwater injection due to clogged gauge.**

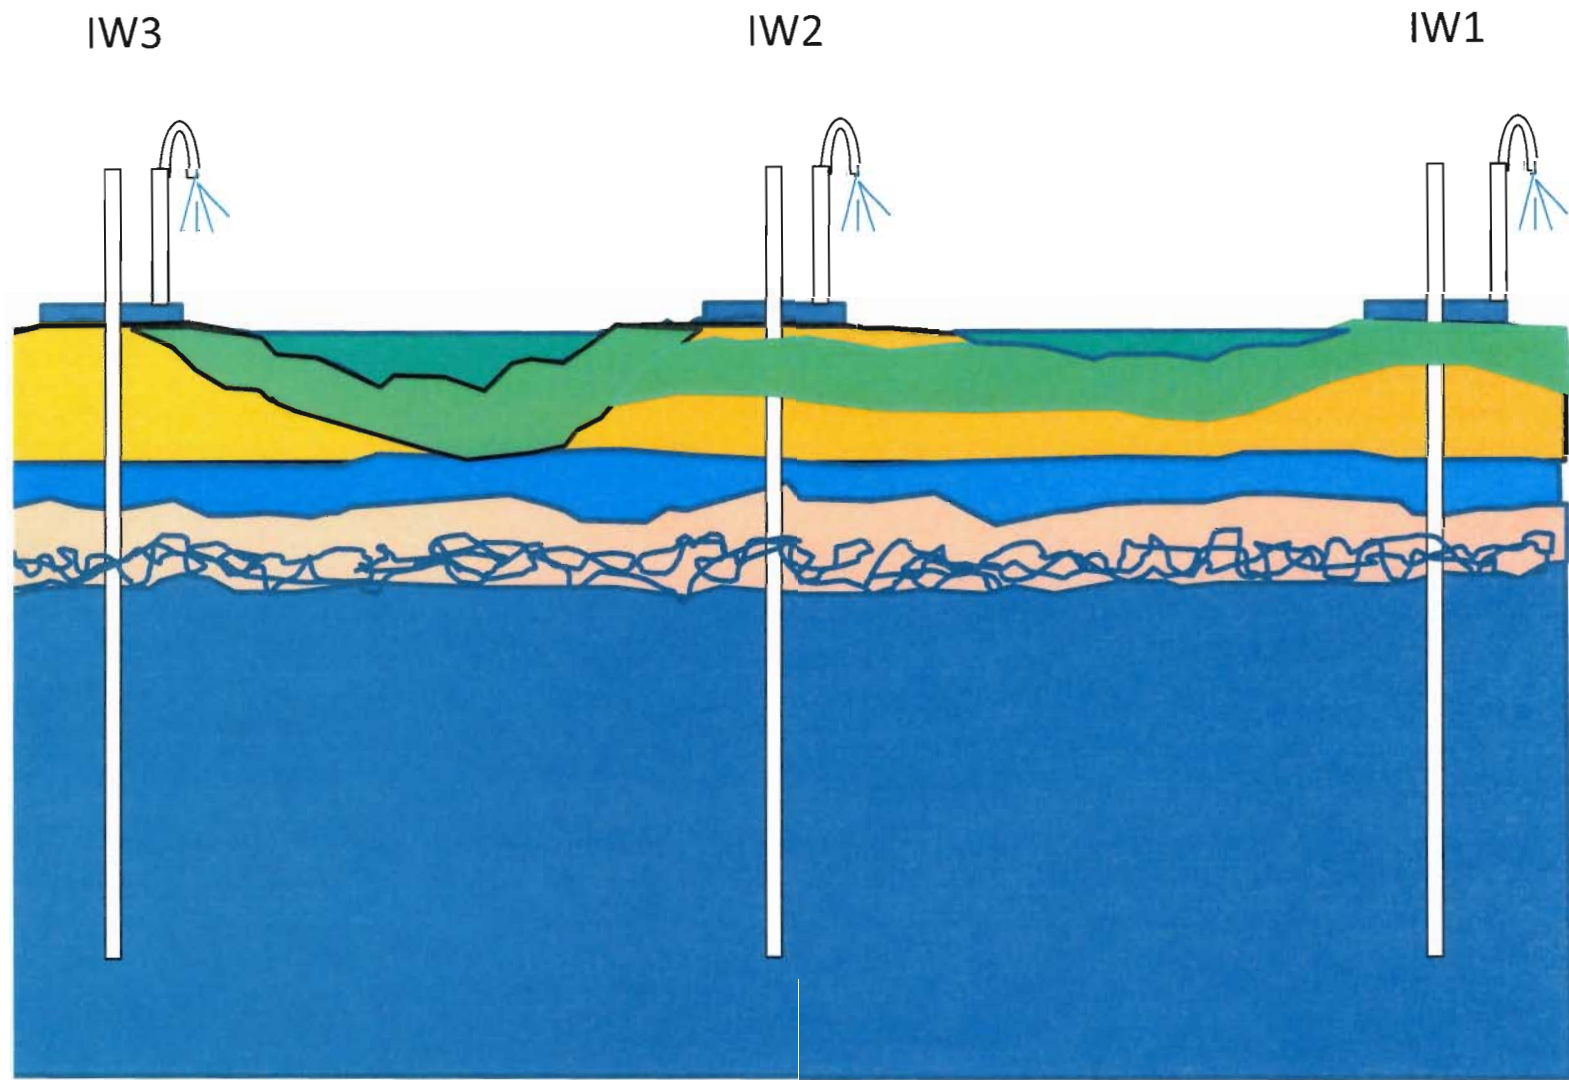
**Flowing snorkels for 2 days saturated soil.**

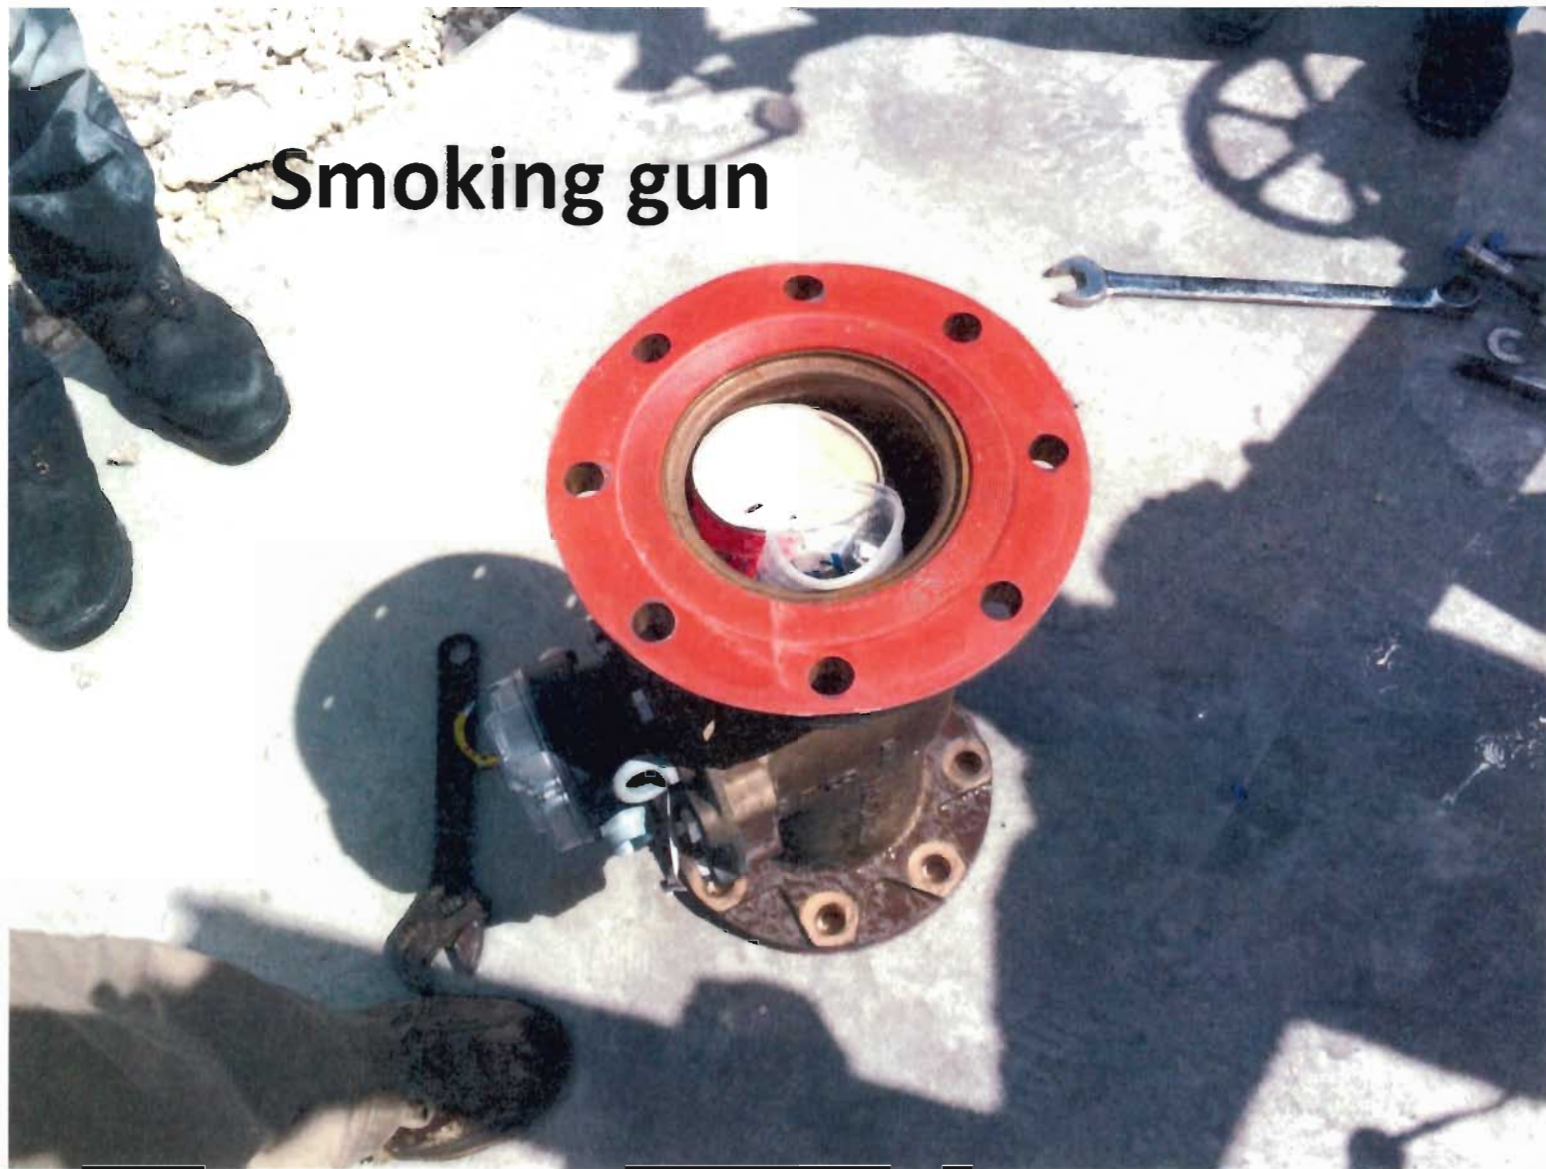
Plastic containers trapped by the flowmeter caused spills through the snorkels and flooding of injection wells area

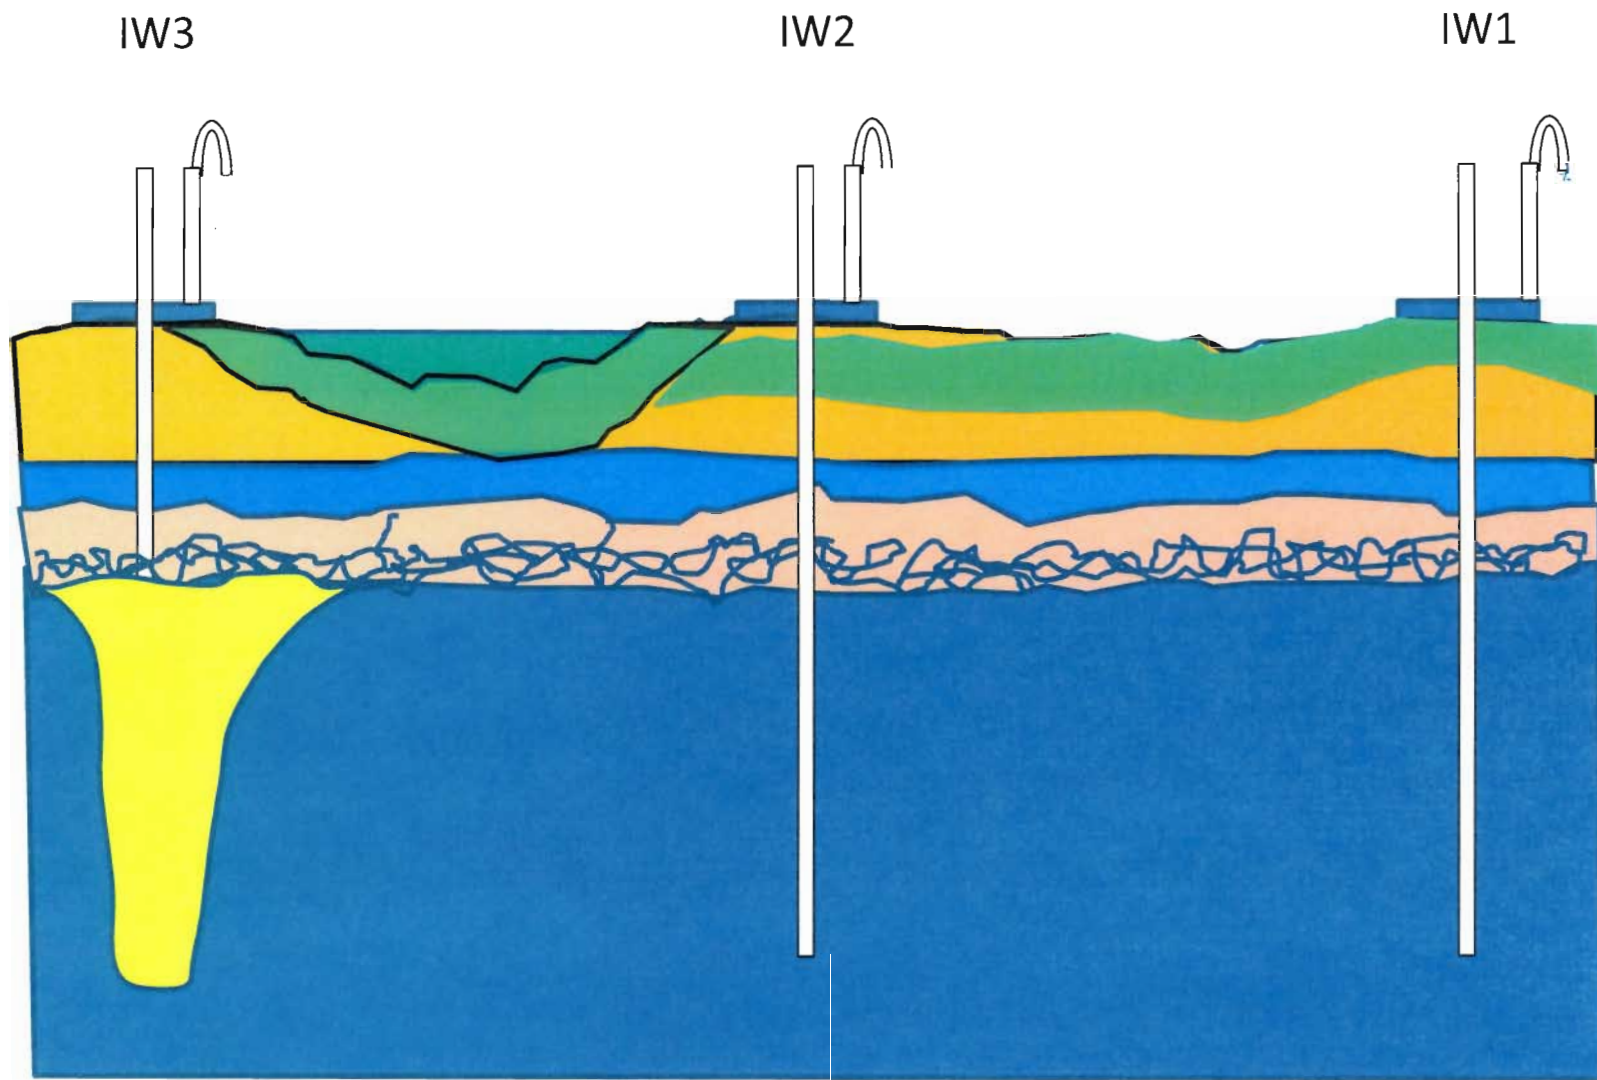
Injected tap water suffers buoyancy due to density differences and moves upward

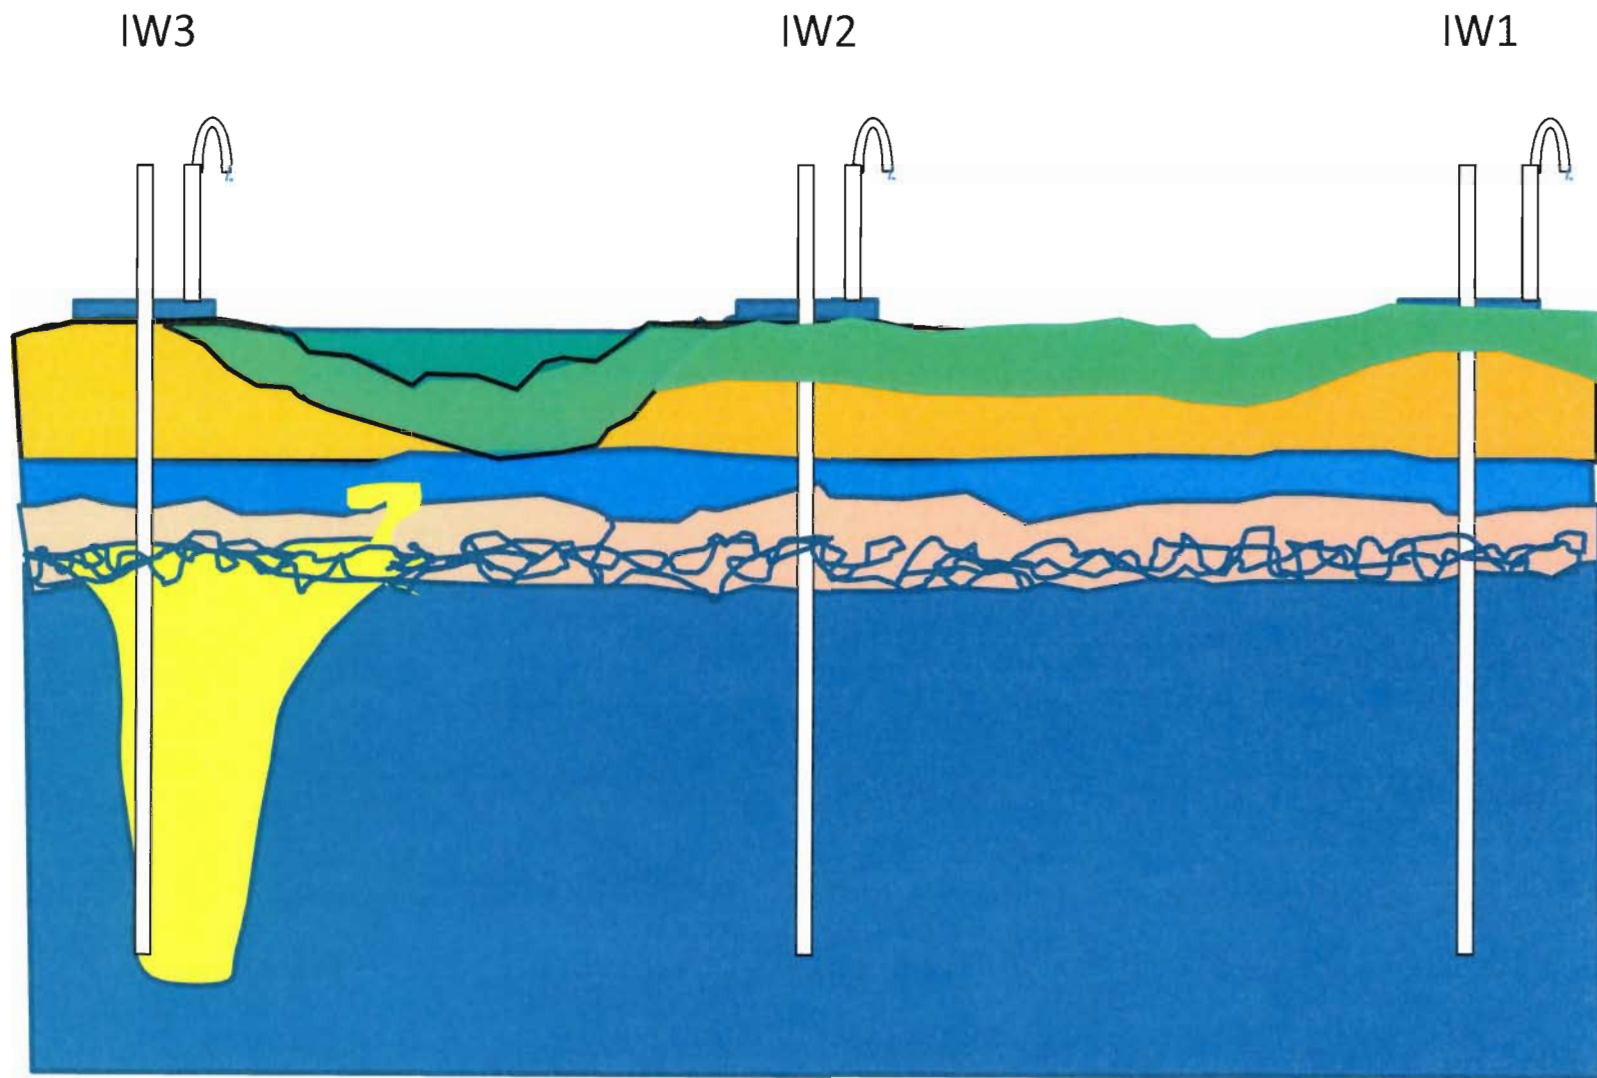
Injected tap water finds a path across the aquitard and moves upward to the unconfined surface aquifer

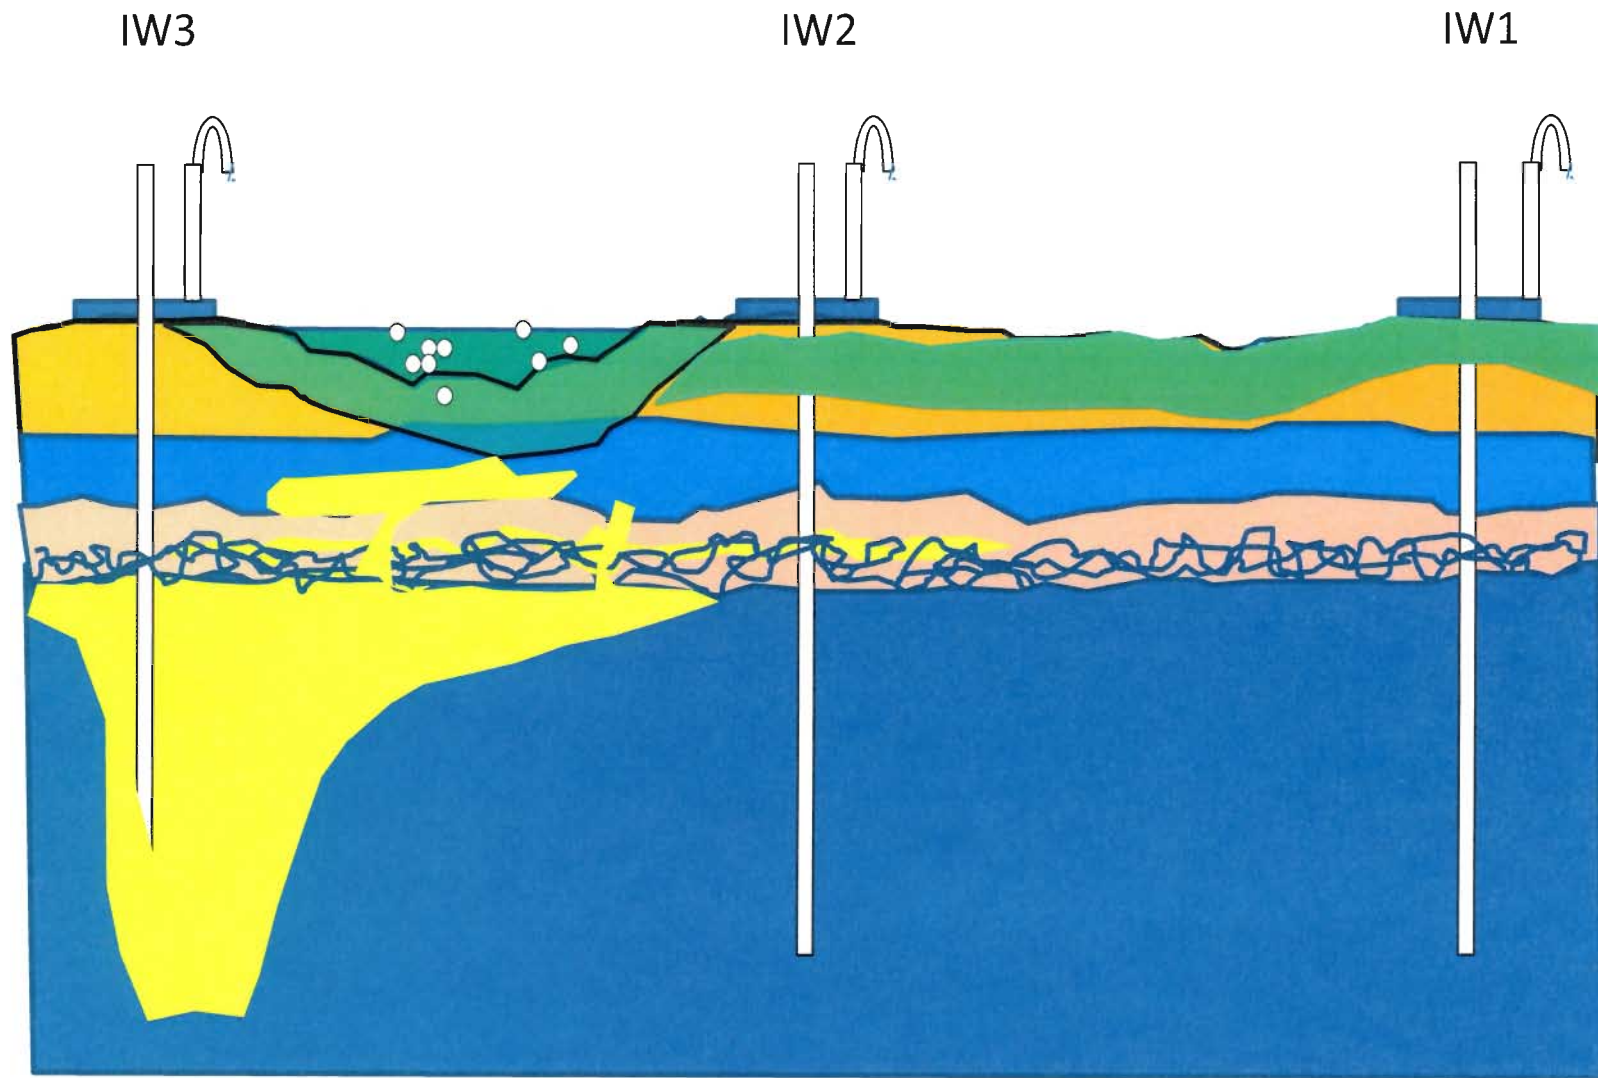
Injected tap water continues to move across the aquitard and moves upward to the unconfined surface aquifer. Pore space is filled with water and air moves to surface bubbling at pond

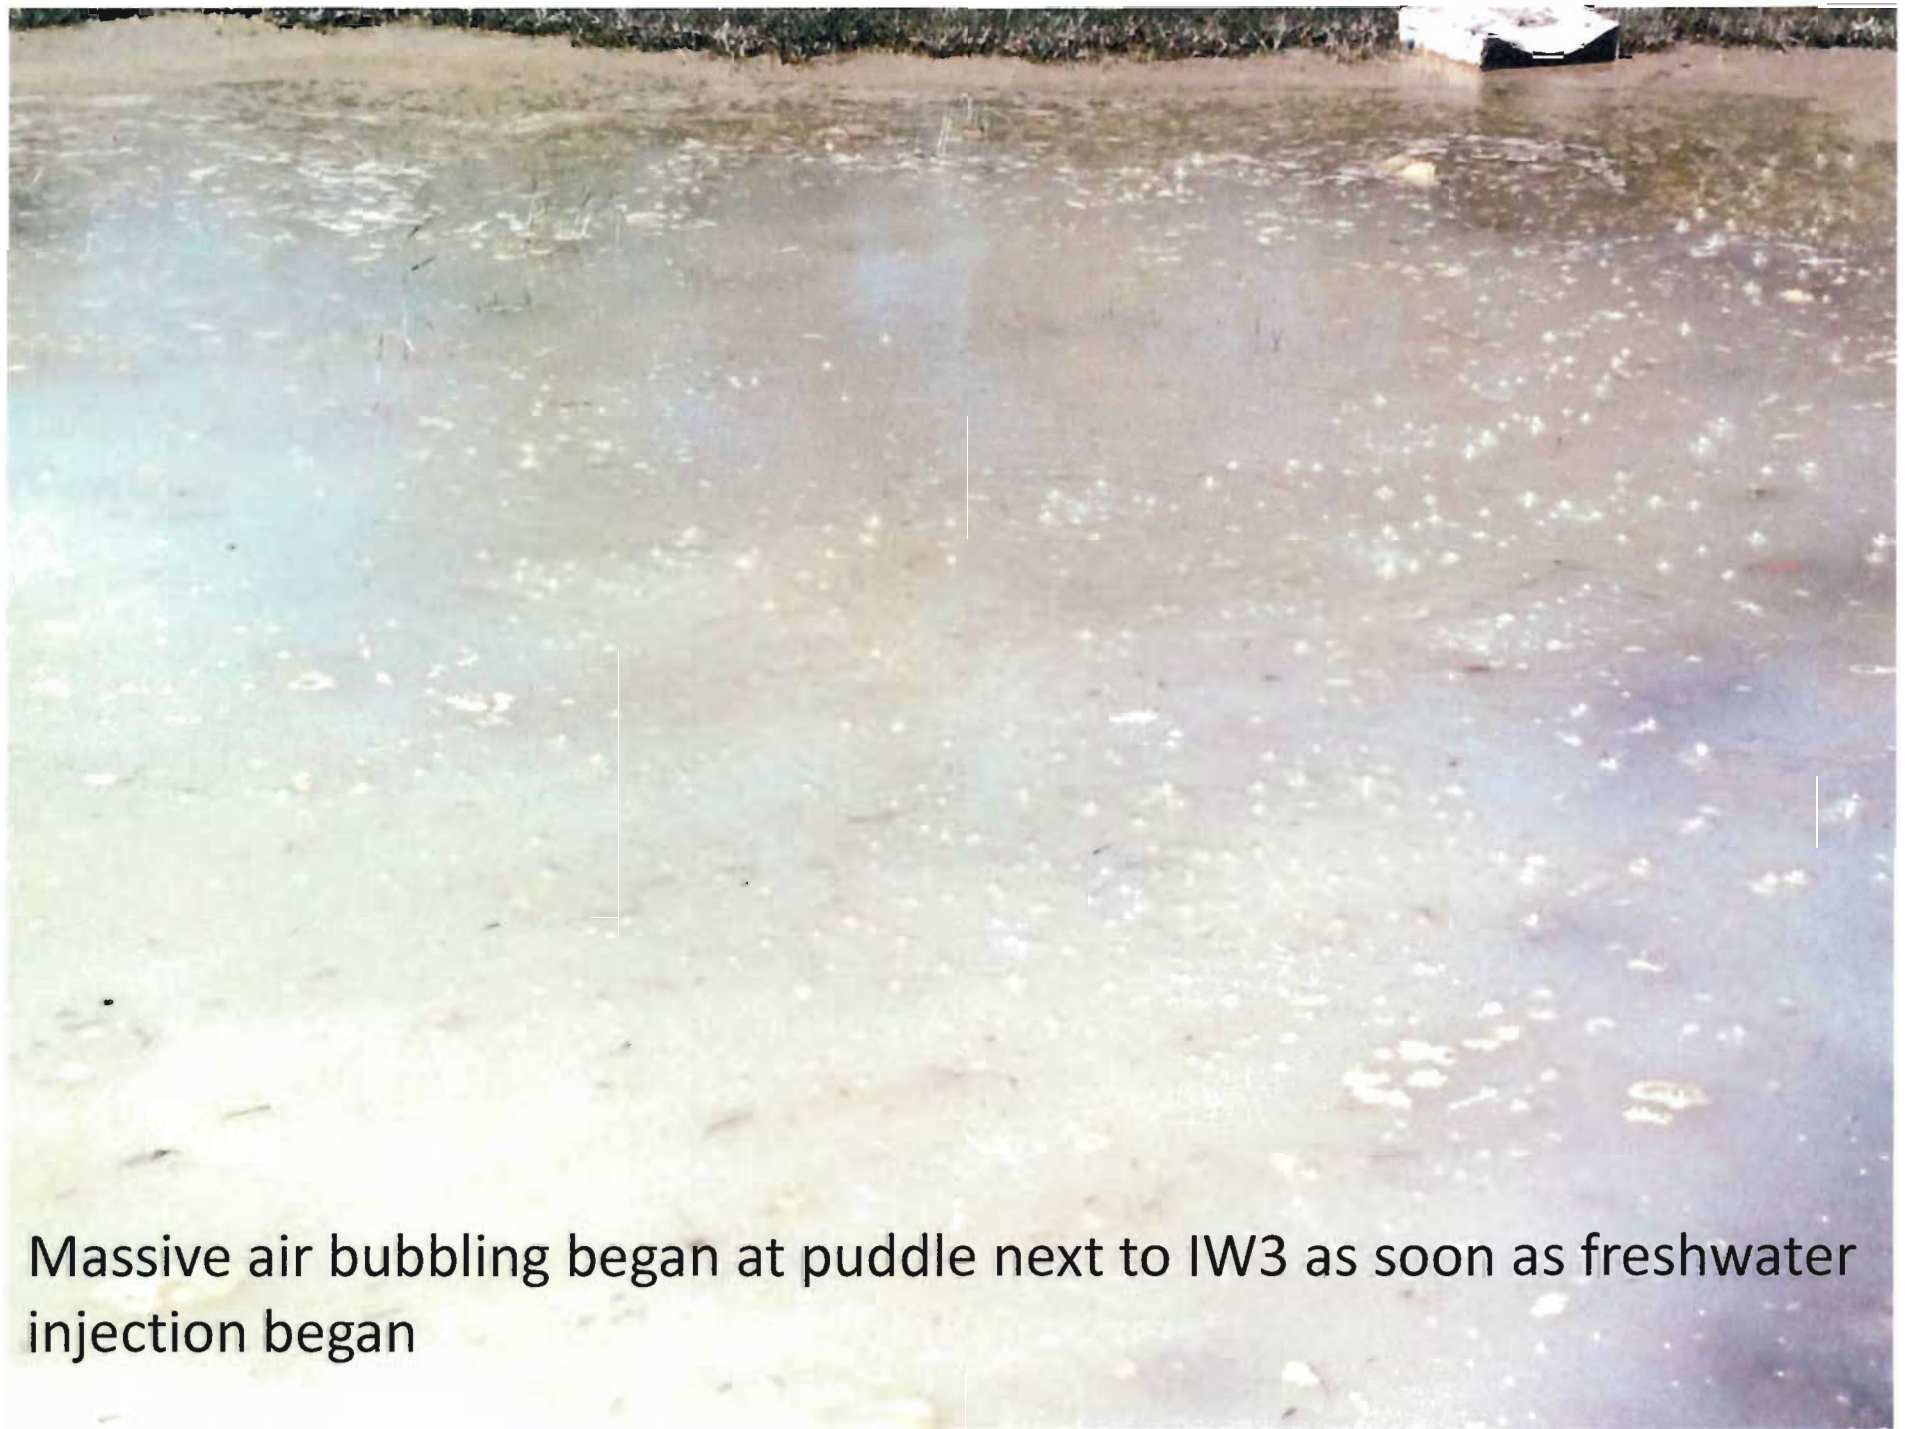
Massive air bubbling began at puddle next to IW3 as soon as freshwater injection began

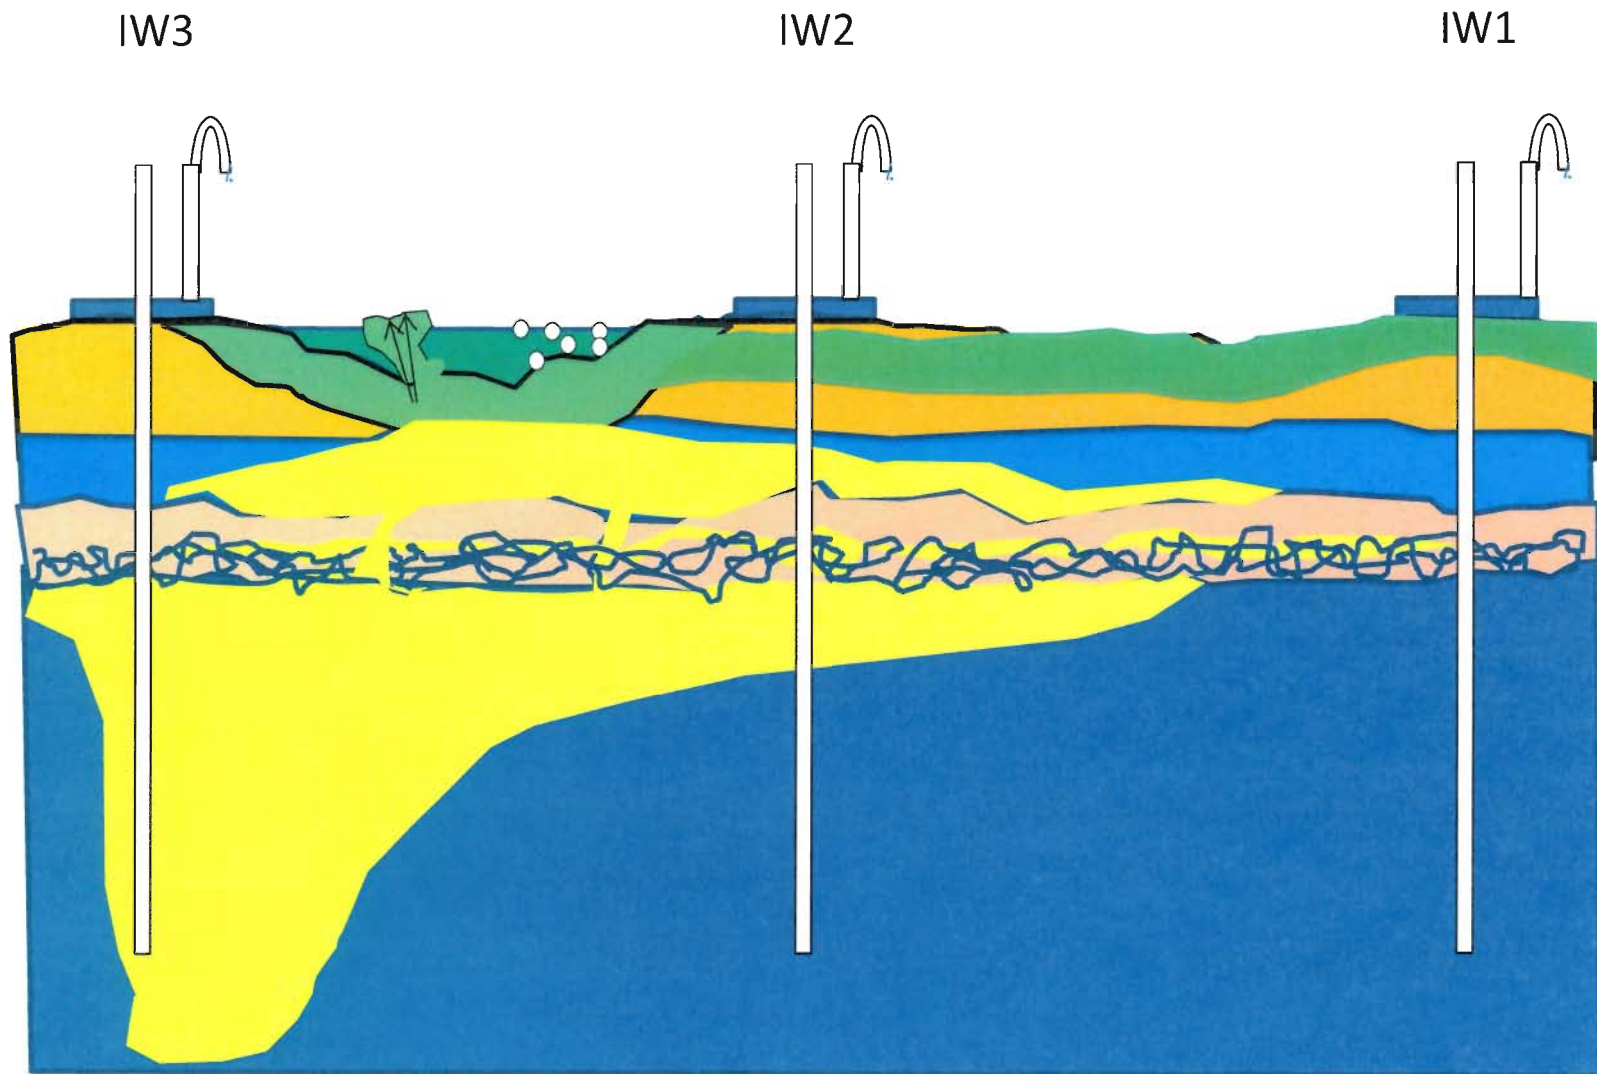
Injected tap water continues to move across the aquitard and moves upward to the unconfined surface aquifer. Pressure building due to hydraulic head makes water vent at puddle bottom and boil in surface
