# Cudjoe Key Project

Update meeting and report

Cudjoe Key, March 19,2015

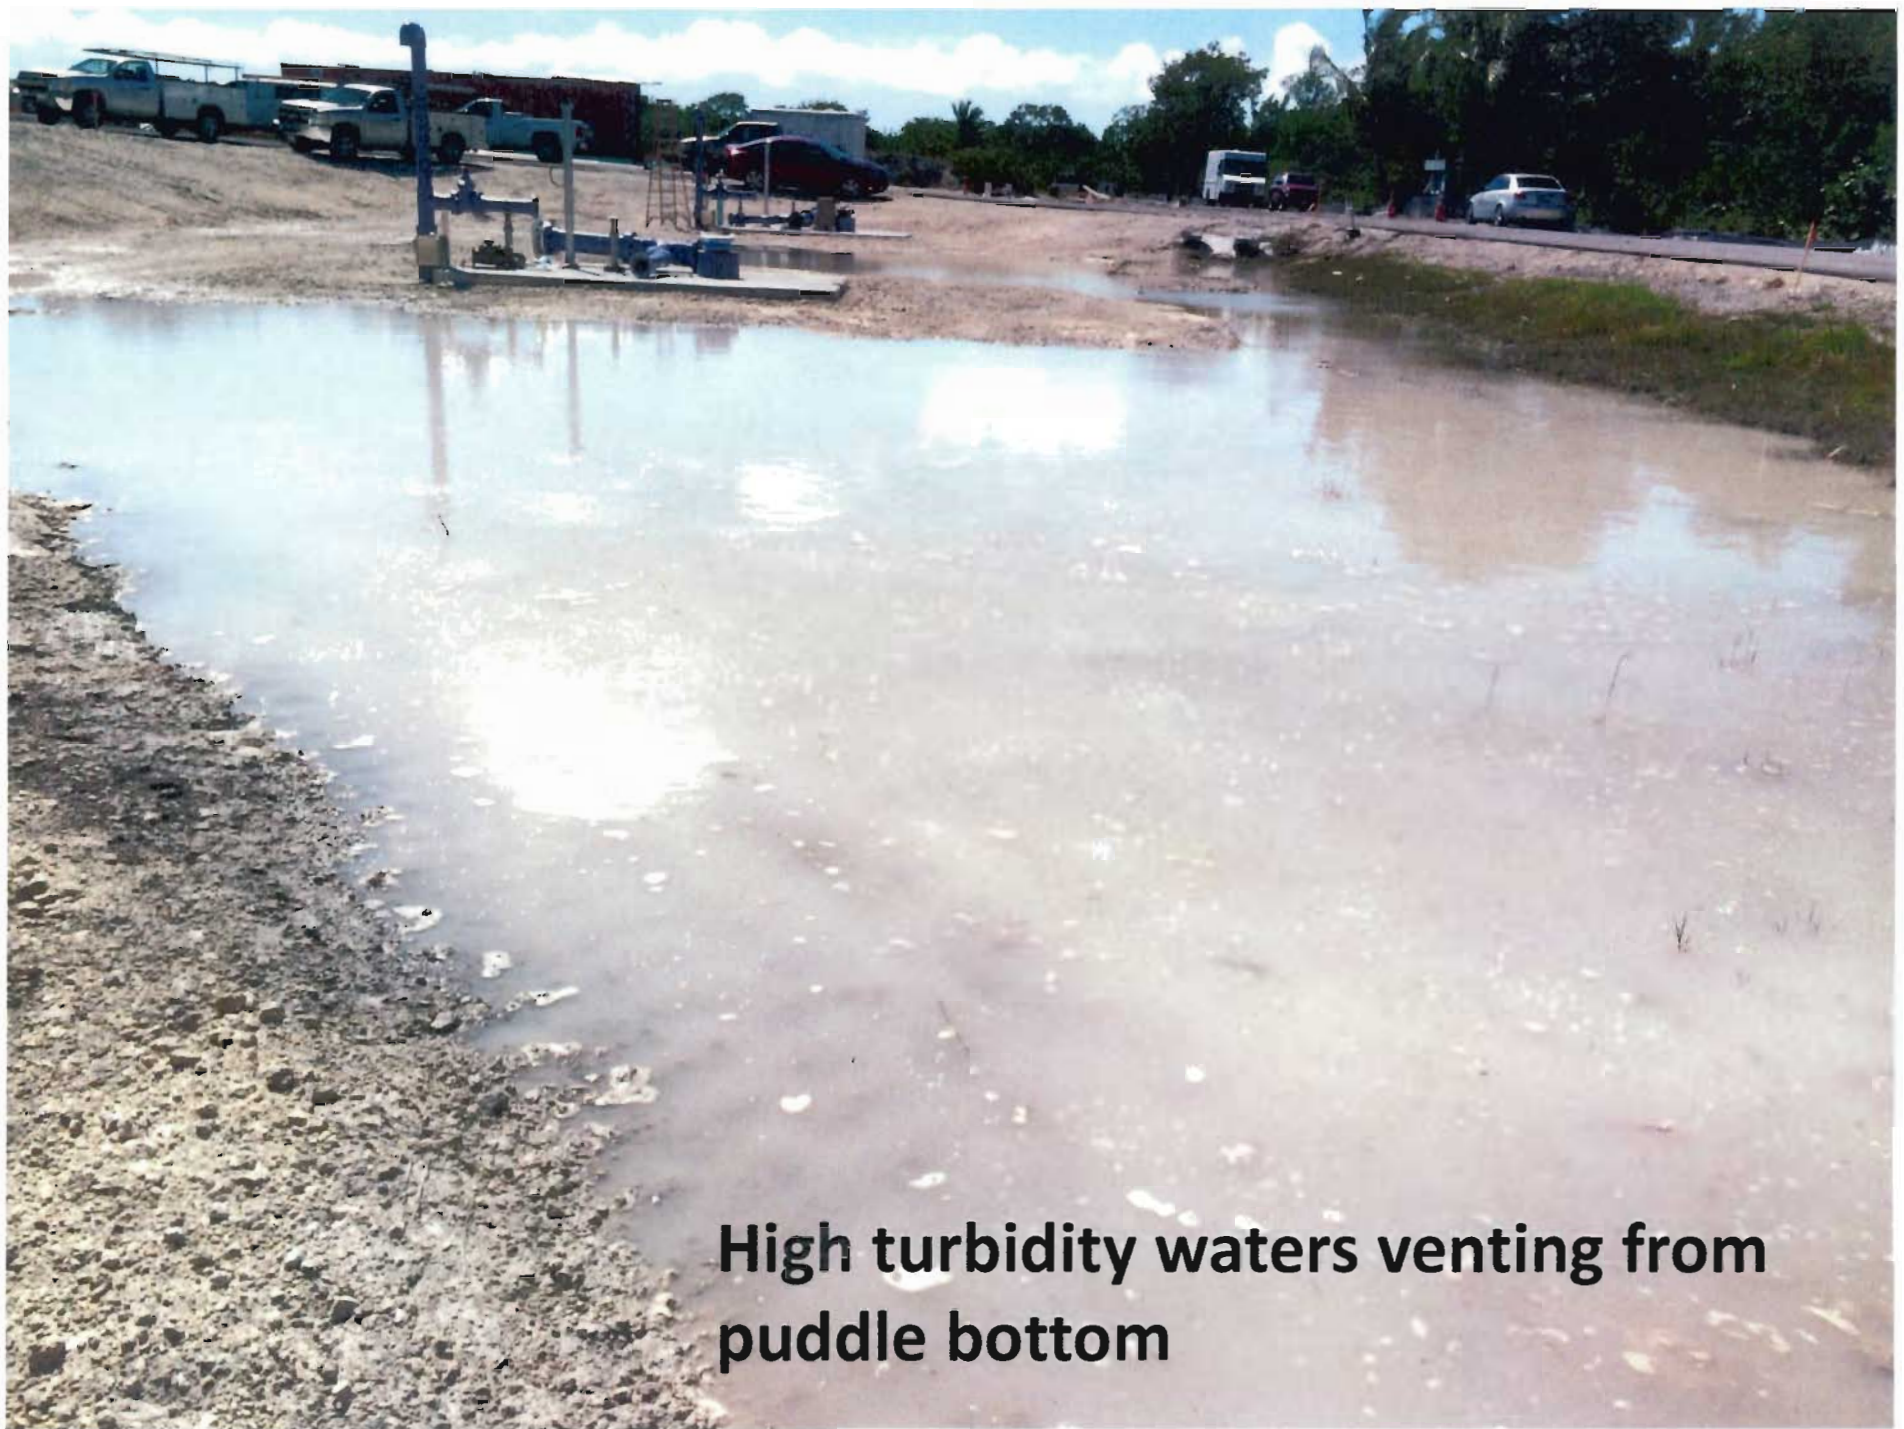
**High turbidity waters venting from  
puddle bottom**

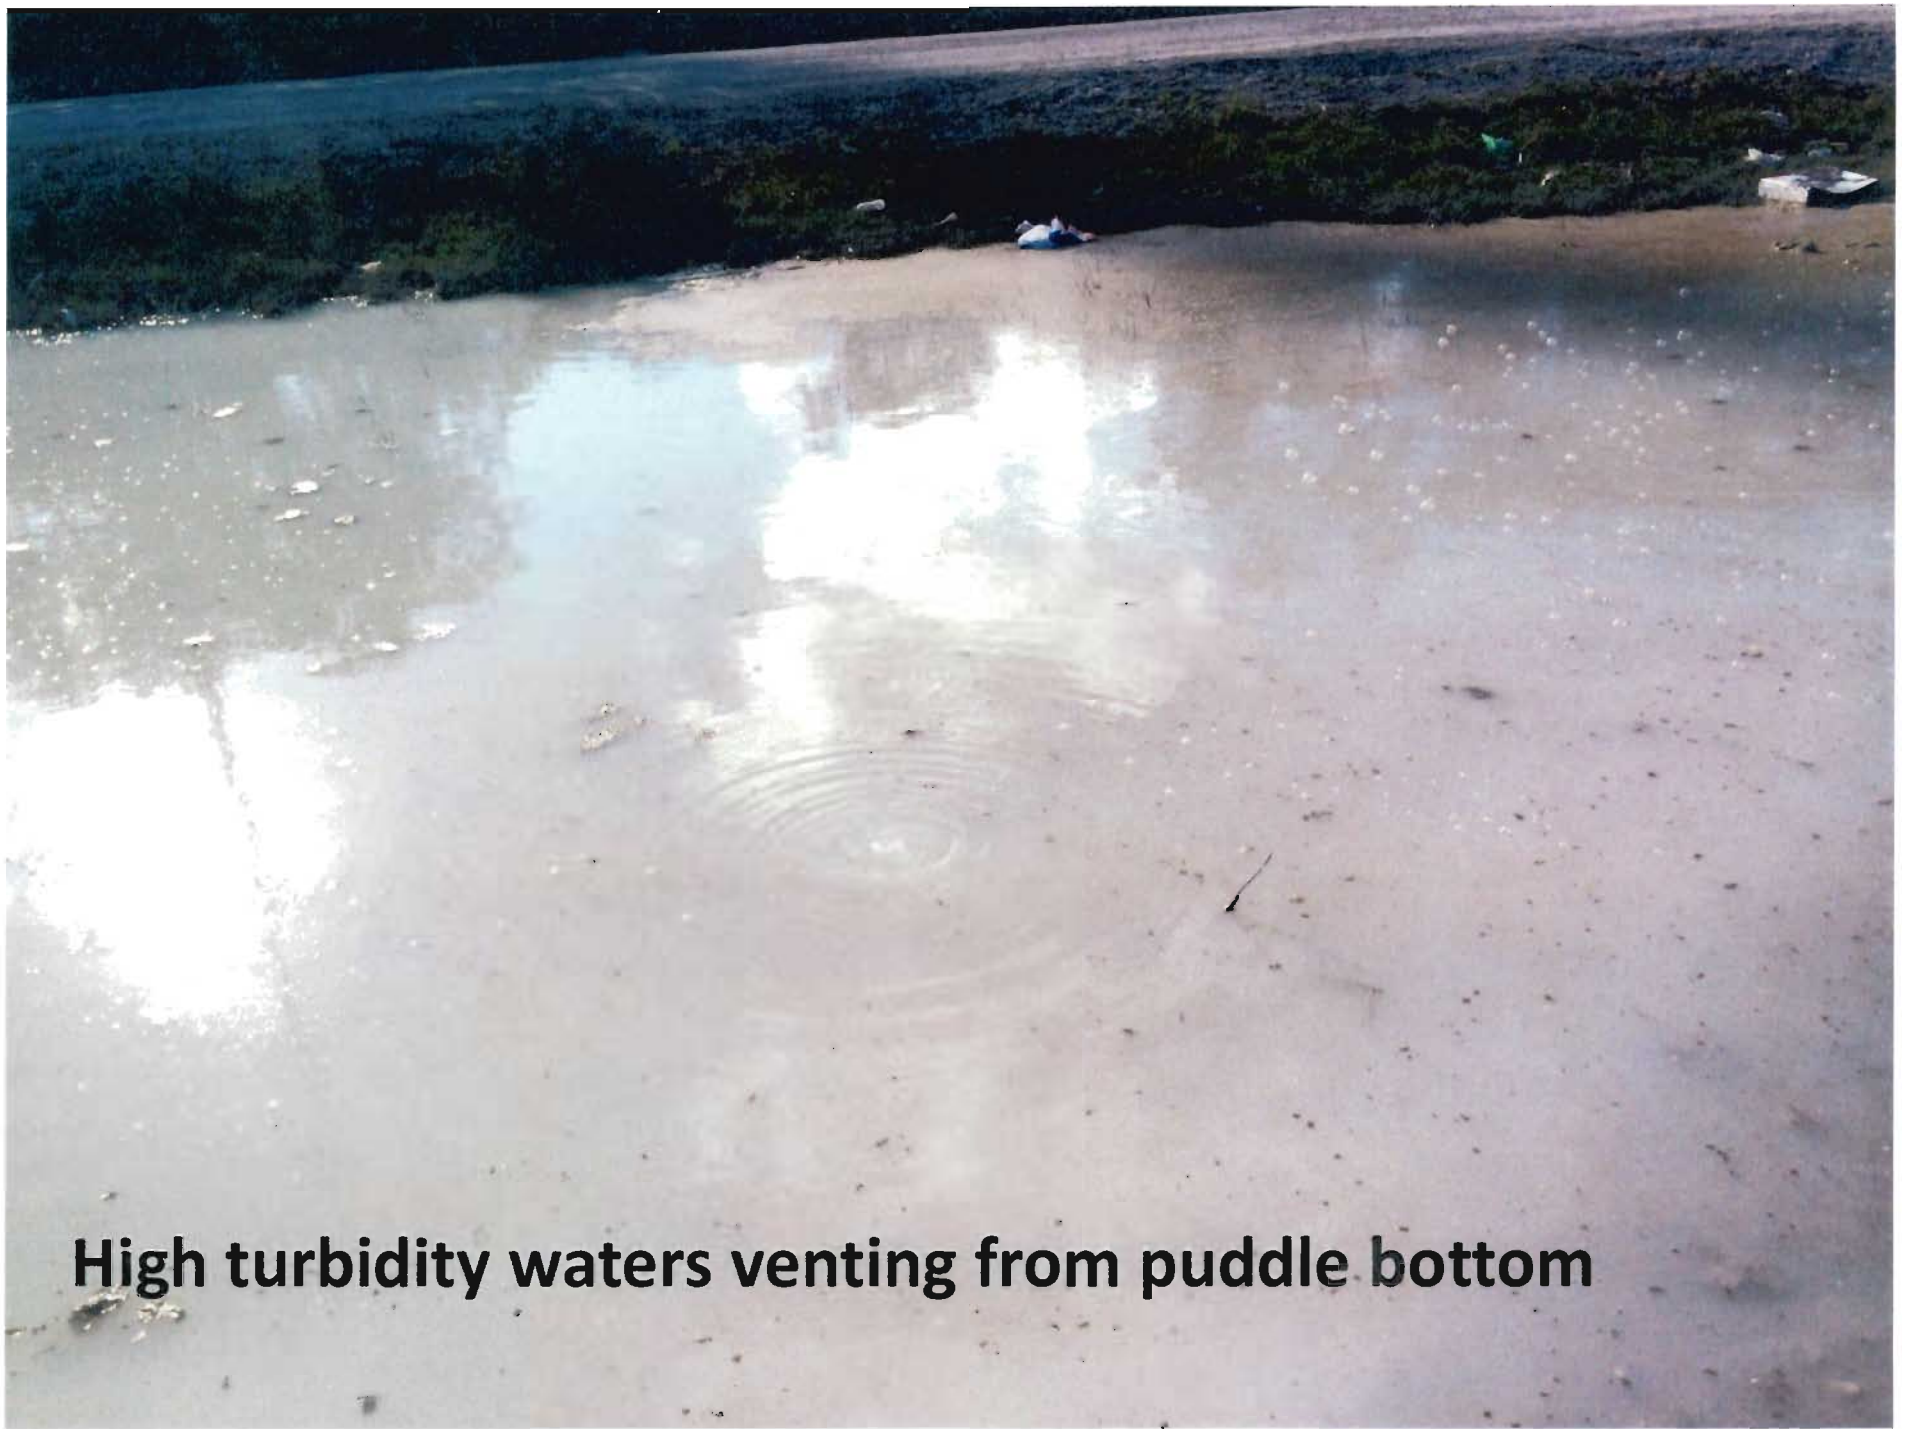
**High turbidity waters venting from puddle bottom**

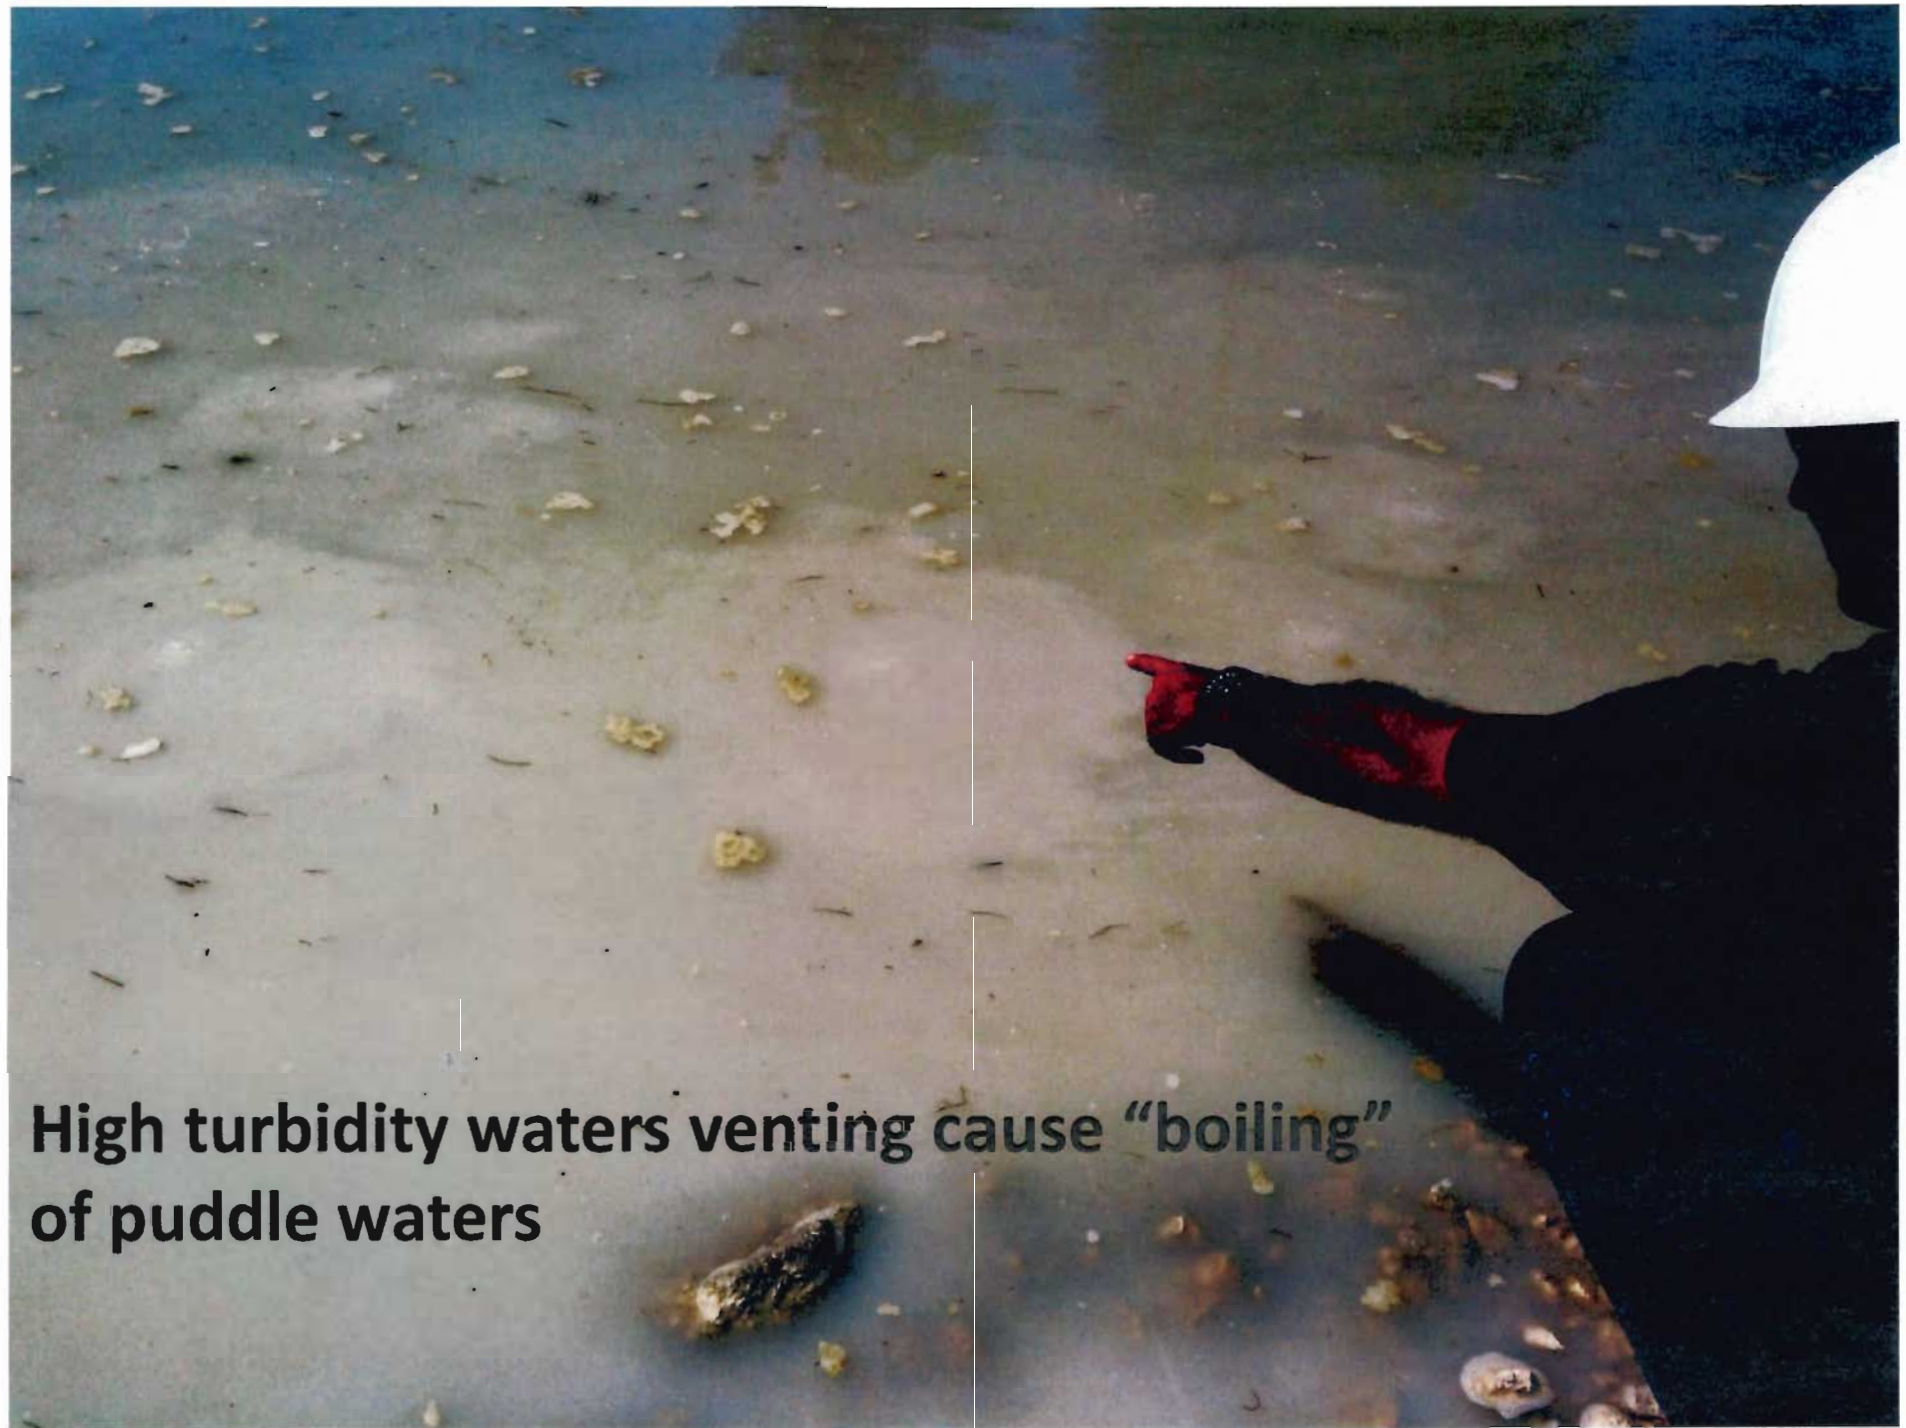
**High turbidity waters venting cause “boiling”  
of puddle waters**

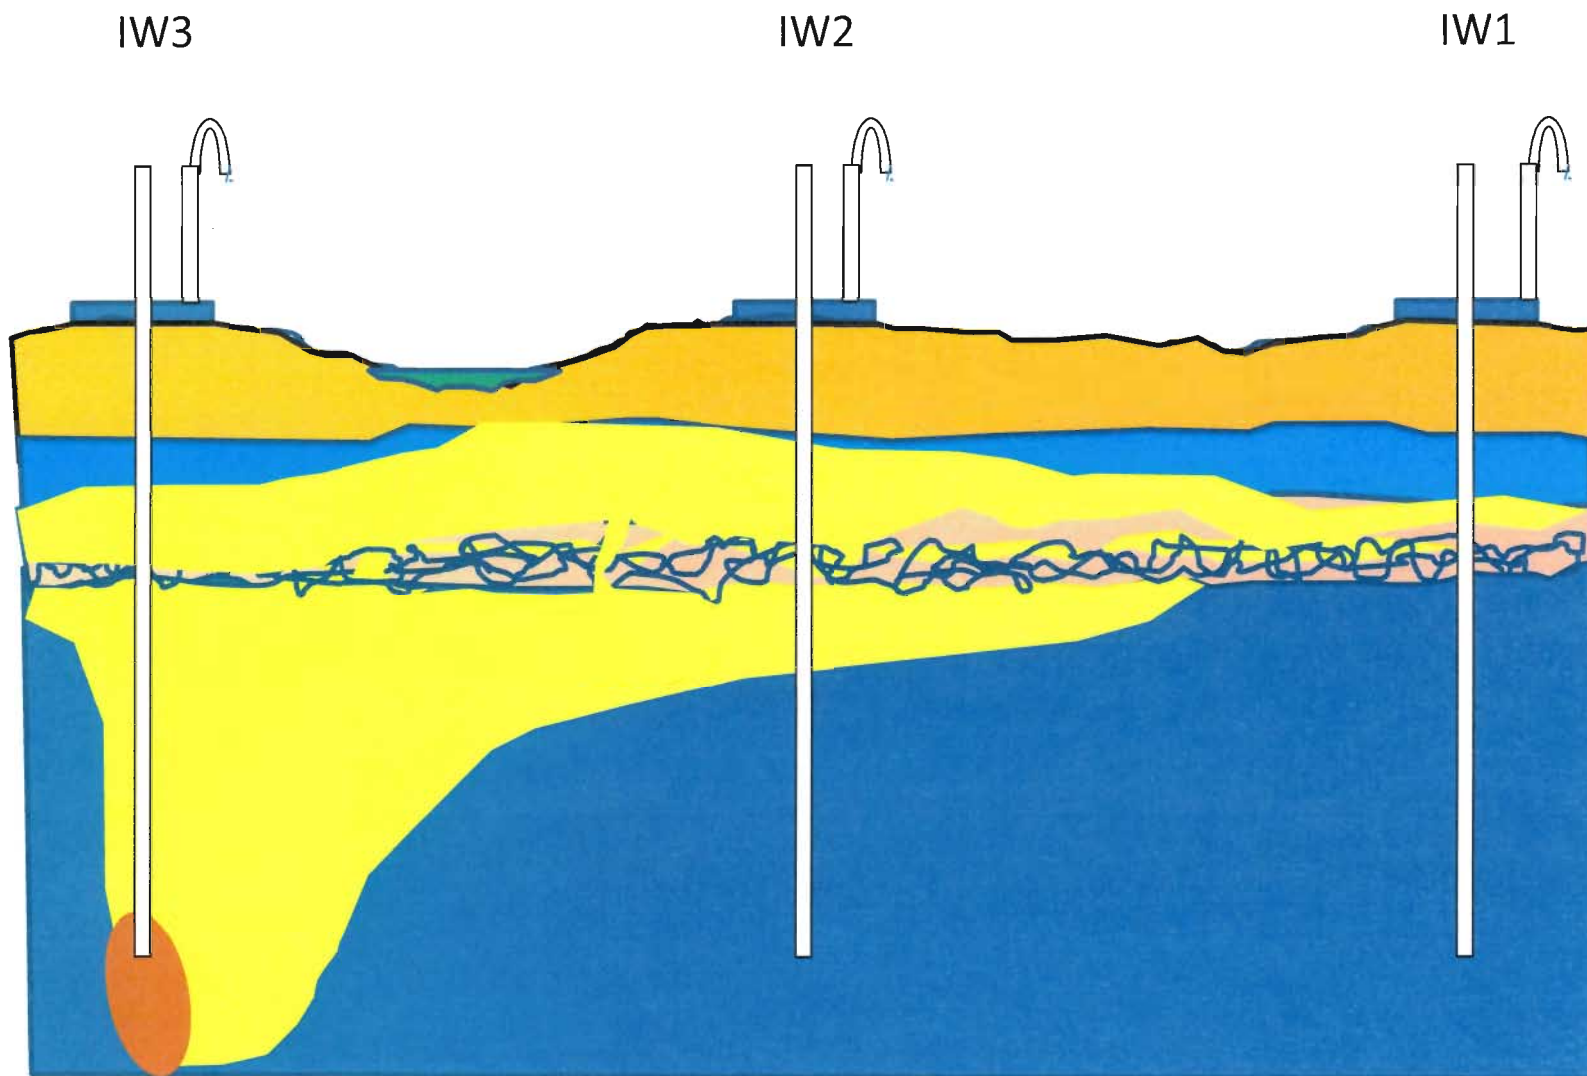
After freshwater injection was halted. The puddle dried out rather fast (1-2 day). Sixty gallons of dye were poured into well IW3 on March 5<sup>th</sup>. Well pipes were reinstalled and freshwater injection was resumed at an average rate close to 420 gpm (~600,000 gpd)

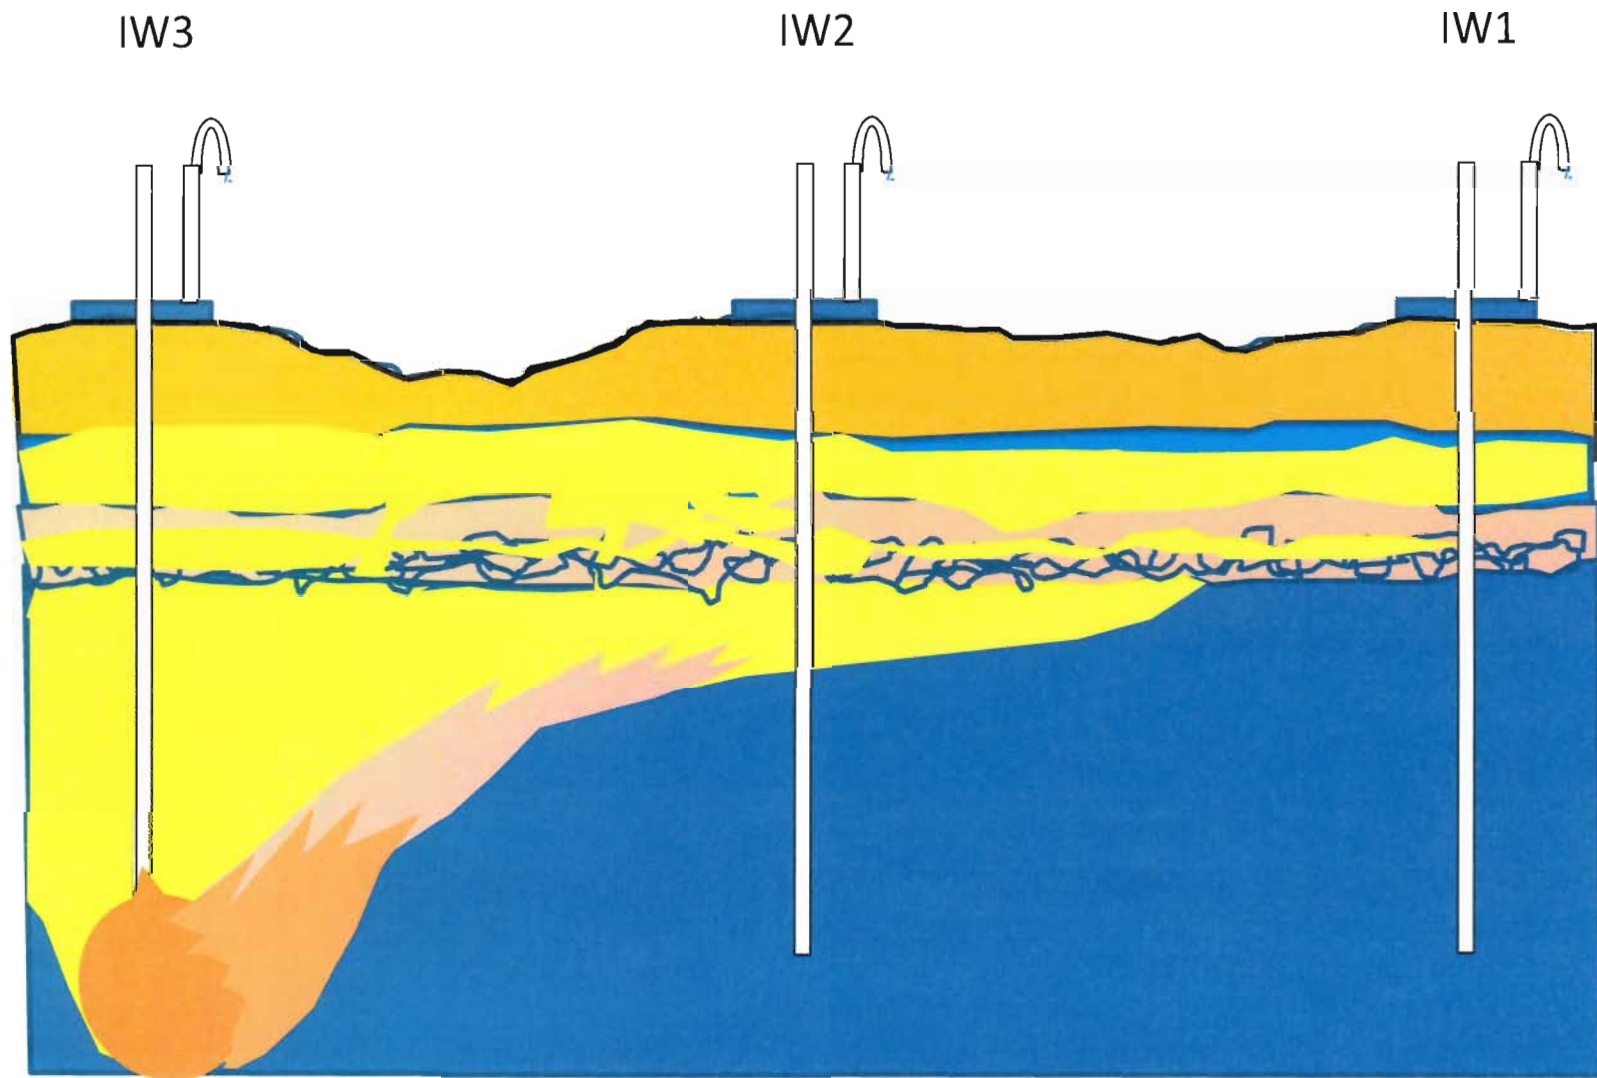
Neither freshening nor dye has been detected nearby IW because: 1) freshwater is still displacing saline water ; 2) Freshwater found a preferential path (e.g. west?)  
In whatever case, if in fact there is a connection across the aquitard, dye will appear somewhere in surface.
